# Wardour Parkland Plan

*Final Report*

*September 2021*

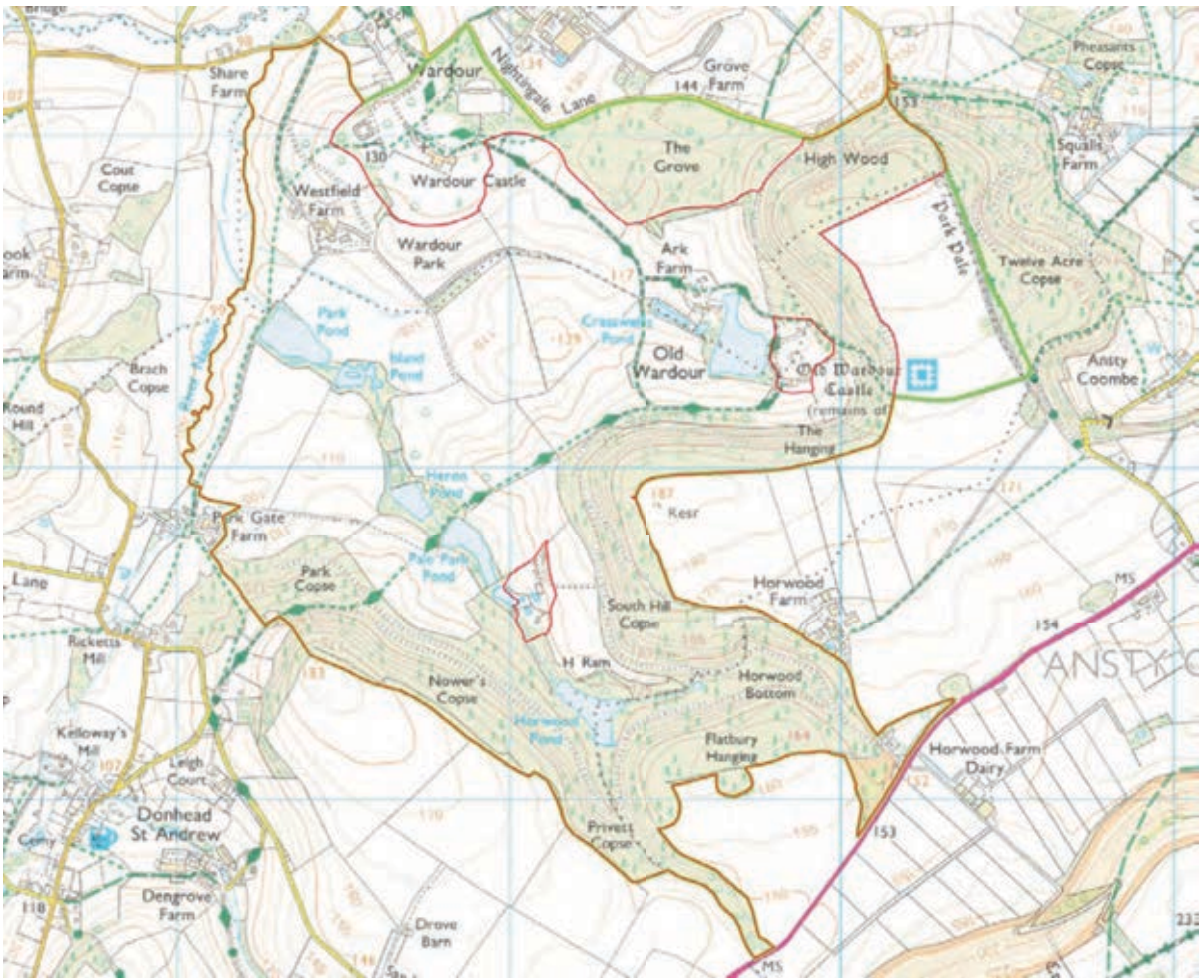
Figure 1.2: The Registered Park and Garden is outlined in green and the study area is within the red line boundary. The detailed study area excludes Pond Close, Old Wardour Castle, the Grove and New Wardour Castle and pleasure grounds/walled garden.

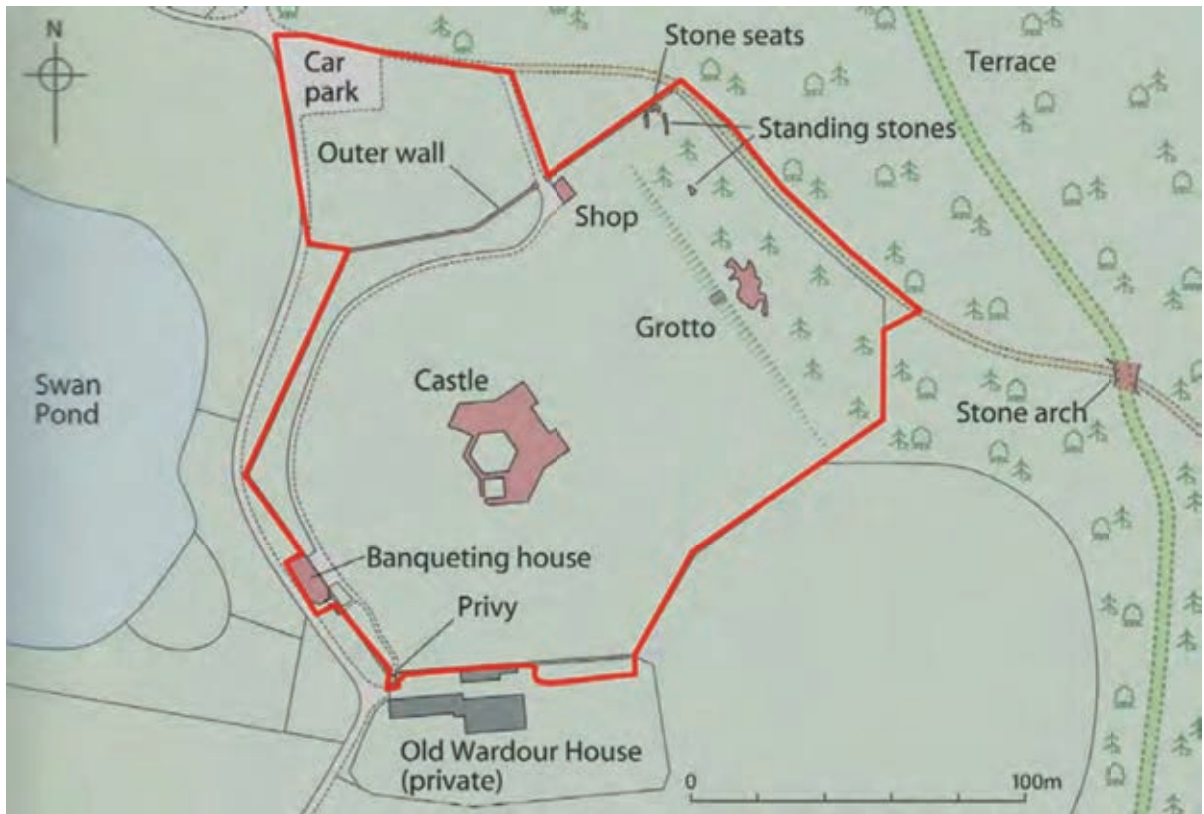
Figure 3.3: Area covered by the English Heritage Guardianship Agreement © Nexus Heritage (January 2015) Old Wardour Castle Conservation Management Plan.

- 3.6 Swan Pond and its immediate environs are managed by Richard Arundell on behalf of Martin and Miranda Thomas.
- 3.7 Old Wardour Castle is owned by Richard Arundell but is under English Heritage Guardianship (see Figure 3.3).

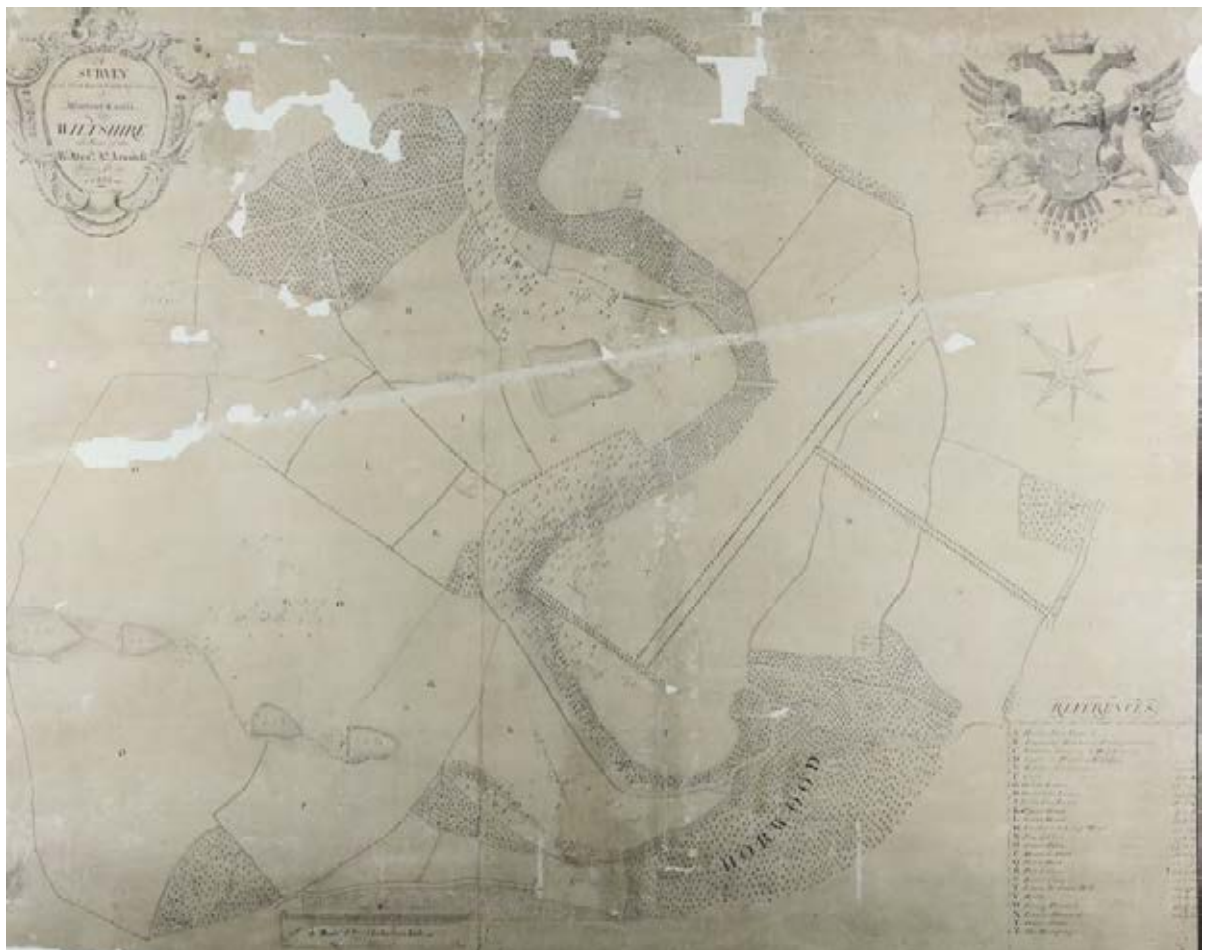
Figure 4.5: Survey of 1753. The ponds, the hanging woods on the escarpment and the ‘etoile’ of rides in the Lady Grove (at this time known as Hare Grove) are the most distinctive features, together with two great rides or avenues in the top park. (Wiltshire and Swindon Archives 2667-21-9H) A full analysis of this map appears in Figure 4.23 at the end of this chapter.

- 4.30 In 1753 a survey was made of the grounds and signed with the initials WD (Stroud, 2009).
- 4.31 Among the most distinctive features are the hanging woods, the étoile or star of rides cut into the Lady Grove (at that time known as Hare Grove), a main and a subsidiary avenue forming a ‘T’ shape

in the top park (the main avenue may be that shown on the 16<sup>th</sup> century ‘mapp’, above), terraces above the Old Castle and a bowling green.

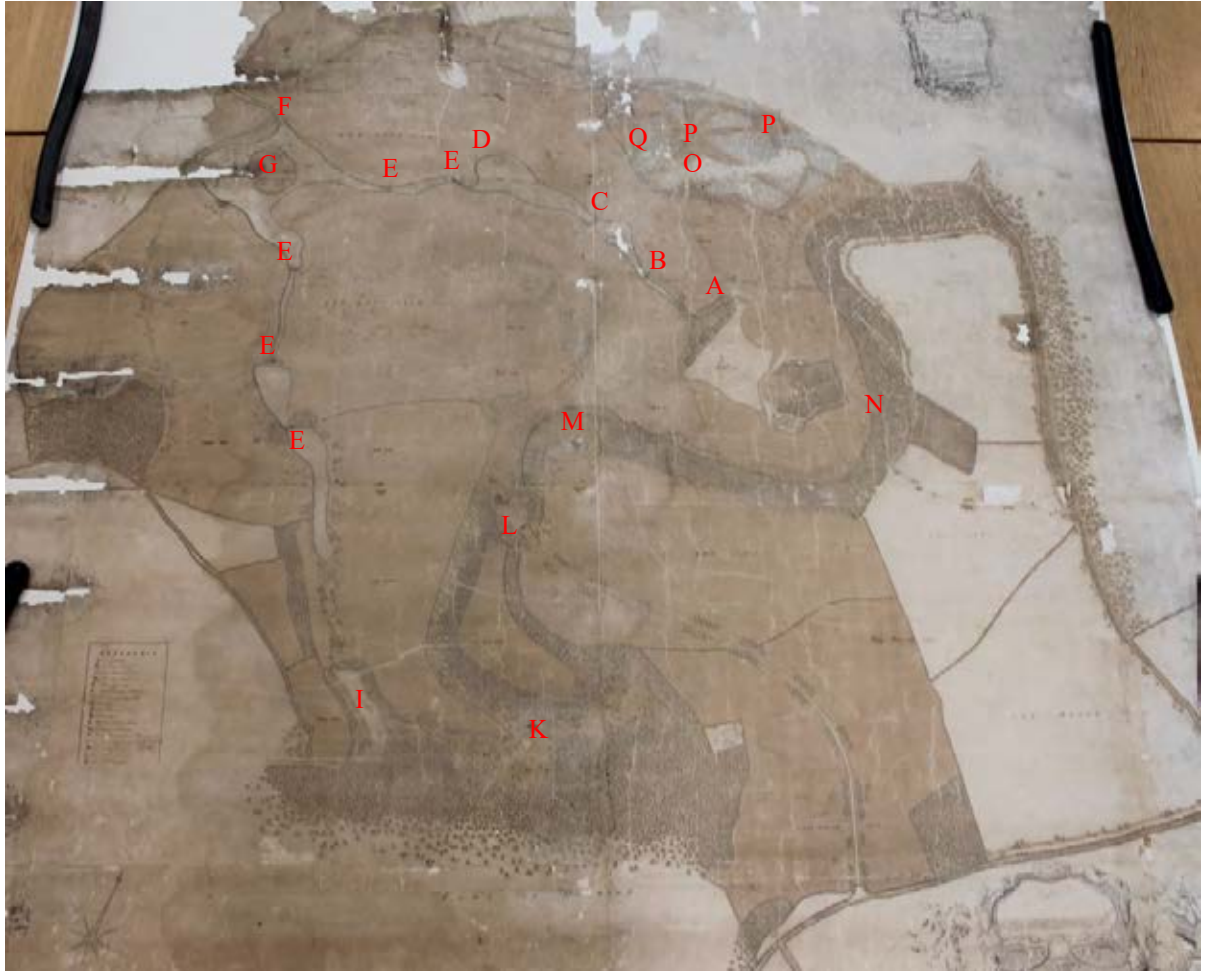
*Figure 4.6: The Richard Woods masterplan, c.1764 (Wiltshire and Swindon Archives 2667-21-10L) Appendix 6 contains detailed extracts of the plan. The plan records the following features: (A) Cold bath, (B) Boat house, (C) Stone bridge, (D) Ice house, (E) Cascades, (F) Palladian bridge, (G) Chinese Temple, (H) Lodge (not identified), (I) Decoy pond, (K) Grotto, (L) Gothic belvedere, (M) Doric alcove, (N) Subterranean passage, (O) Green house & menaziry house at back, (P) the two light Tempels out of the Castle garden, (Q) Ionic temple and (R) Obelisque (not identified).*

- 4.40 The 1764 plan included the proposed house in roughly its present position, two large lakes between the Old Castle and the new house (the New Castle) and the 35 structures, among which was a grotto, a belvedere, a Chinese temple and a Palladian bridge. Woods also proposed a terrace and a two-mile drive from the main Salisbury to Shaftesbury road, designed to make the most of the descent from the

high ground to the low. Much of this work was never carried out or carried out only in part, so that the intended effect was never fully realised. The Lady Grove, for example, was proposed to be filled with ornamental buildings but only an ice-house and a temple were built, neither of them extant. Similarly, the great body of water Woods proposed in the west of the park remained unexecuted (as did a similar, later, proposal by Brown), and the park is perhaps the poorer for it.

interesting to note that the Woods plan (Figure 4.6) shows a proposal to create a string of ponds along this valley.

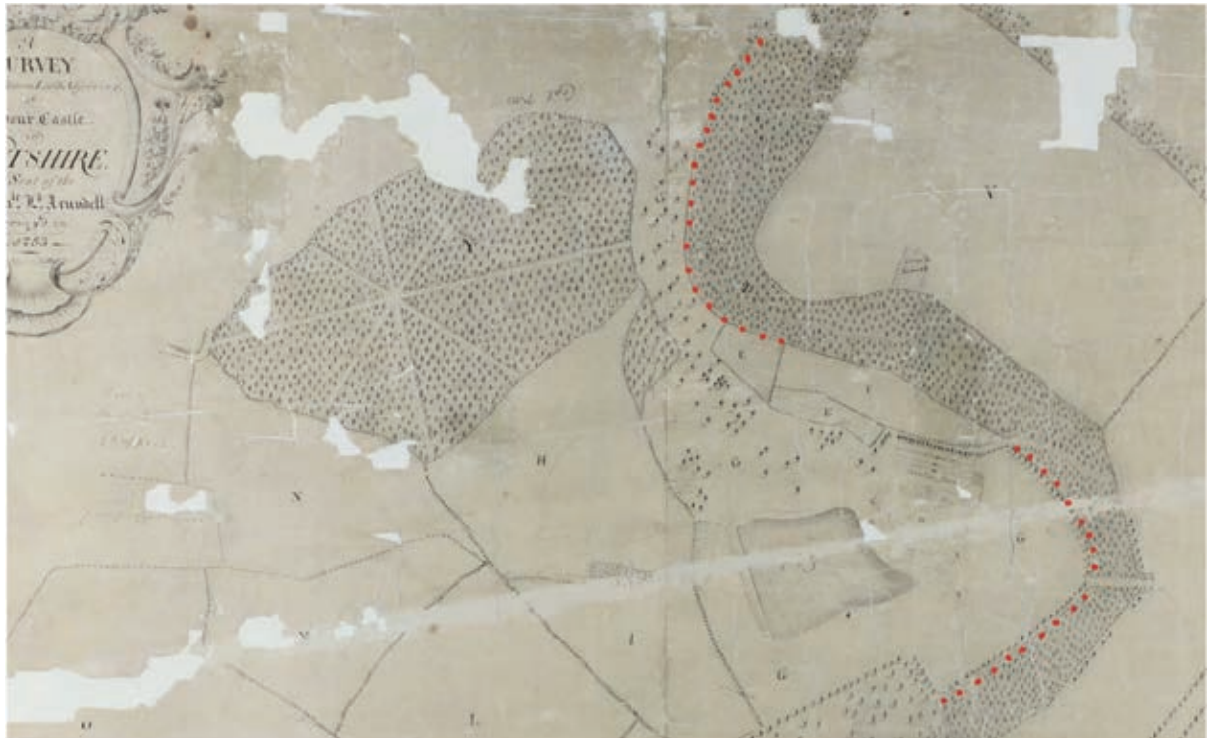
Figure 4.7: Extract of the 1753 survey (Wiltshire and Swindon Archives 2667-21-9H). The red dotted lines show the lines of trackways that might have been later used and incorporated into the Great Terrace.

- 4.45 A close review of the historic maps perhaps adds to the uncertainty over the authorship of the Great Terrace design. The 1753 survey appears to show that the line of the terrace may have been partially in place before Woods was at Wardour. A route between the Hangings and Horse Lease (Z and G respectively) which ends at the Kitchen Gardens can be discerned, perhaps suggesting a functional rather than ornamental approach at that time. The route does not continue north of the field marked as Croft (F on the survey), but the mapping suggests that it might continue from the entrance from the east to the south following the then base of the wooded escarpment (see Figure 4.7).

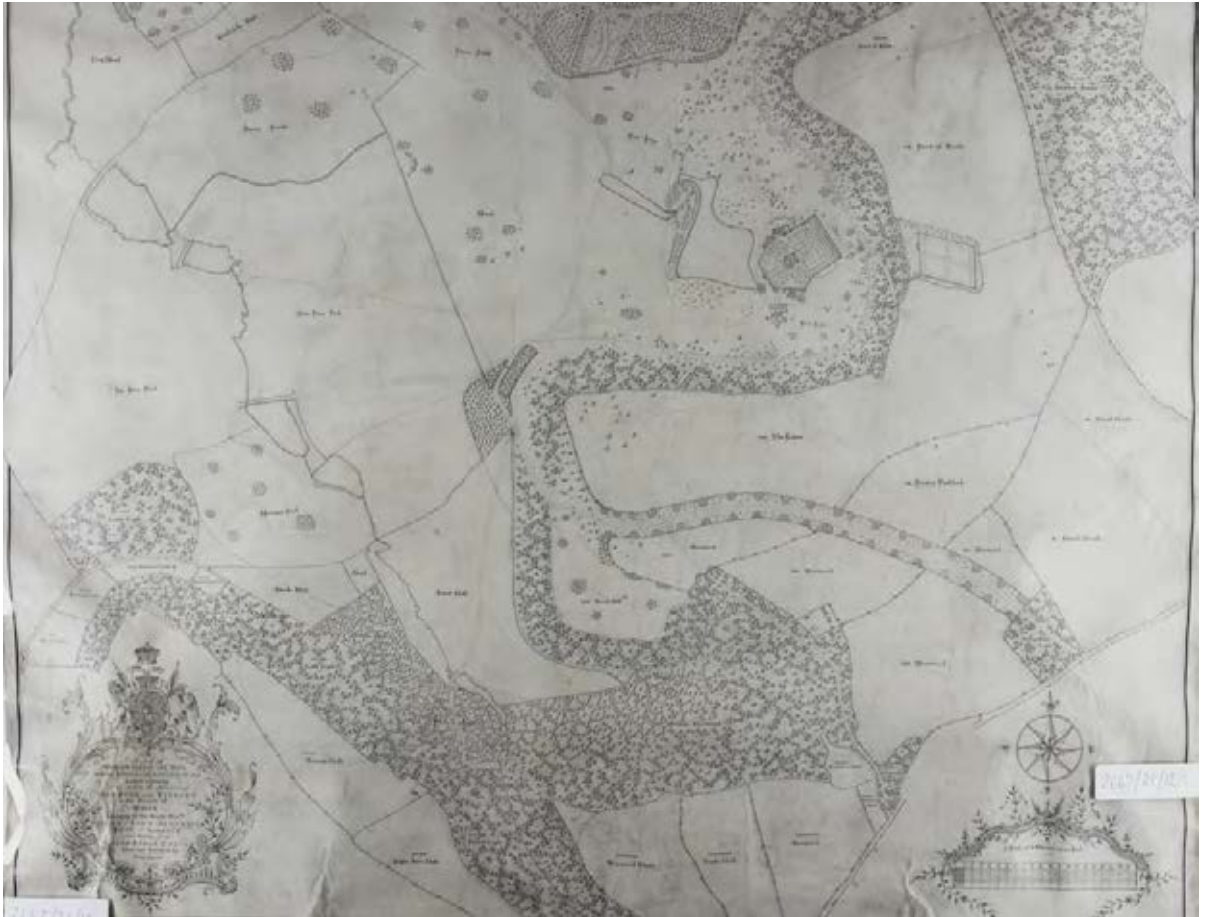
Figure 4.8: Ingman's survey 1773, recording the landscape just after Woods had been dismissed. (Wiltshire and Swindon Archives 2667-21-12H). See Figure 4.25 for a full version of the survey.

- 4.46 The Ingman survey of 1773 (Figure 4.8) shows that the Great Terrace tapers out towards its western end and does not join up with any of the other approach drives, suggesting that this was work in progress. Woods had proposed to terminate the western end of the terrace with a Doric alcove, so that could also be why the terrace appeared unfinished.

- 4.51 The landscape left by Woods is recorded in detail in a survey by George Ingman and in broader strokes on Andrews and Dury's county map of Wiltshire, both issued in 1773.

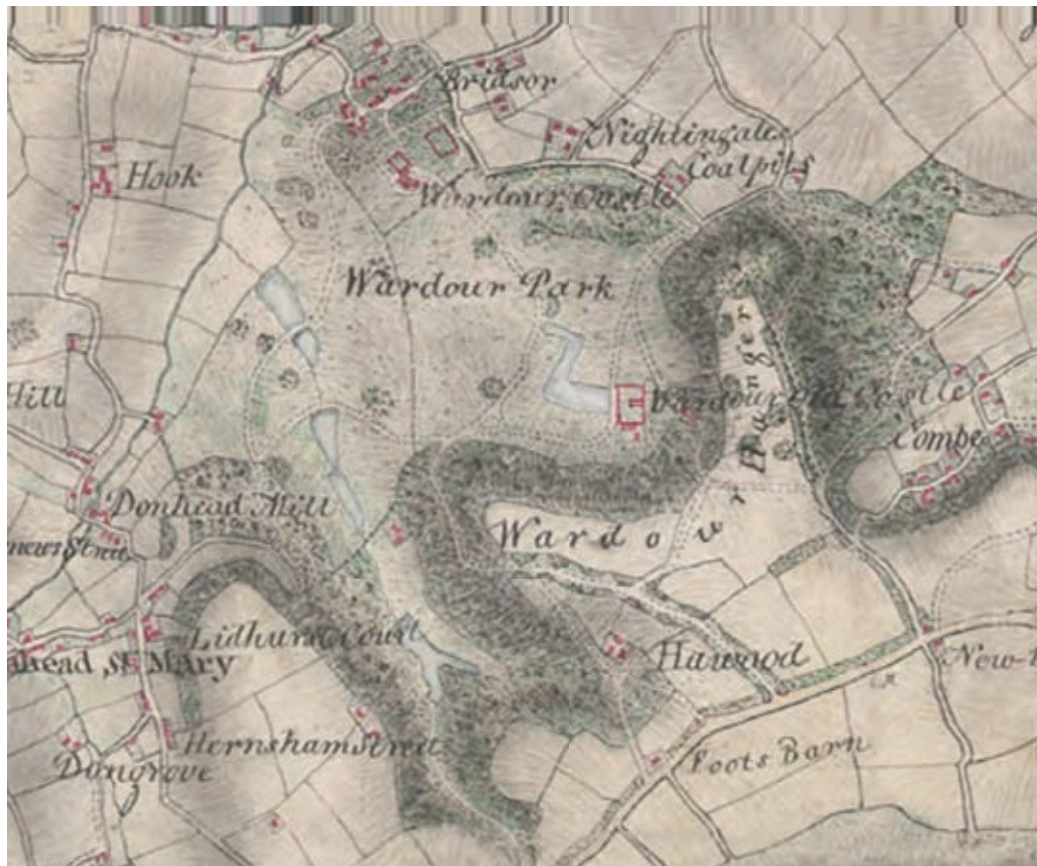
Figure 4.13: Ordnance Surveyor's Drawing, 1807. Wood's approach from the south is clearly shown. Clumps indicate the landscape park. All the mapped routes are designed so that they pass bodies of water.

- 4.69 At about the time that Britton and Warner were describing the park, the Ordnance Surveyor’s Drawing was issued (1807, Figure 4.13). This captures the park near to its zenith. The extent of the park can be gauged from the depiction of parkland clumps. Although the large bodies of water that had been contemplated by the 8<sup>th</sup> Lord had not been executed, every route crossing the park passes a water body, thereby maximising the impact of what water there was. The approach from the Salisbury to Shaftesbury road retains its regular punctuation of planting, some 30 years after Woods had designed it. A second approach from the Shaftesbury – Salisbury road is also evident, seemingly passing close to Horwood Pond, descending the escarpment and crossing the park between Park Pond and Island Pond, towards the New Castle.

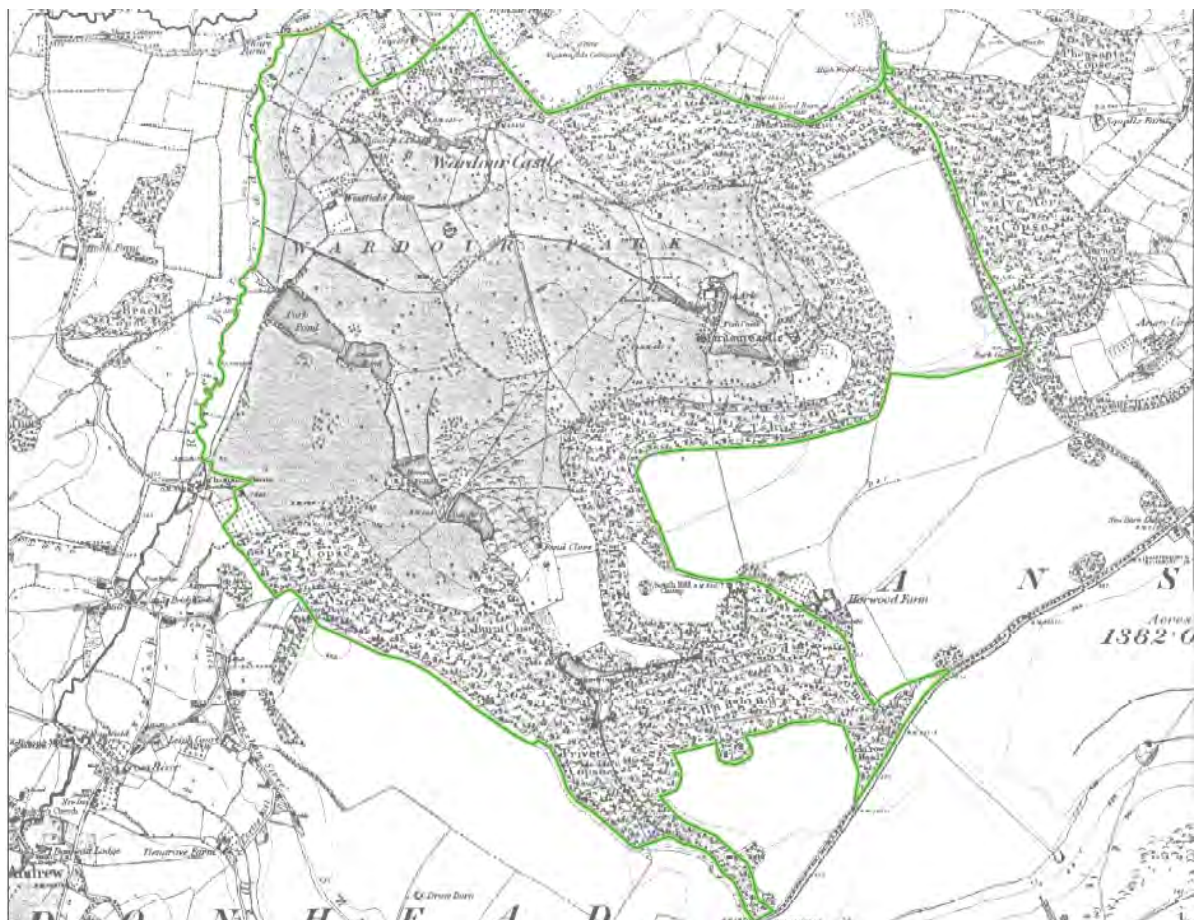
Figure 4.20: Ordnance Survey 1:6 inches map of 1890 with Registered Park and Garden shown in green.

- 4.93 In 1890, the Ordnance Survey First Edition was published at a scale of 1: 6 inches. Comparing this with the Ordnance Surveyor's Drawing of 1807, it seems there has been little change to the main features of the park. The water bodies appear to occupy approximately the same locations and have neither been added to, nor filled in. The limits of the parkland in 1890, helpfully shown with shading, bear comparison with the area shown as parkland in 1807. Perhaps the biggest change is in the amount of land given over to woodland, particularly in the area of Horwood Farm, where the trees of Horwood Bottom and Flatbury Hanging coalesce with Woods' approach. Within the park proper, there are several large groups of trees, but what is striking is the large number of single trees. It is also clear from the 1890 map that the park is subdivided into many different parcels, many more than in the Ingman survey of 1773.

- 4.94 An additional higher terrace above the Great Terrace is recorded on the 1890 OS map, along with a greater number of drives and rides through the woodlands.

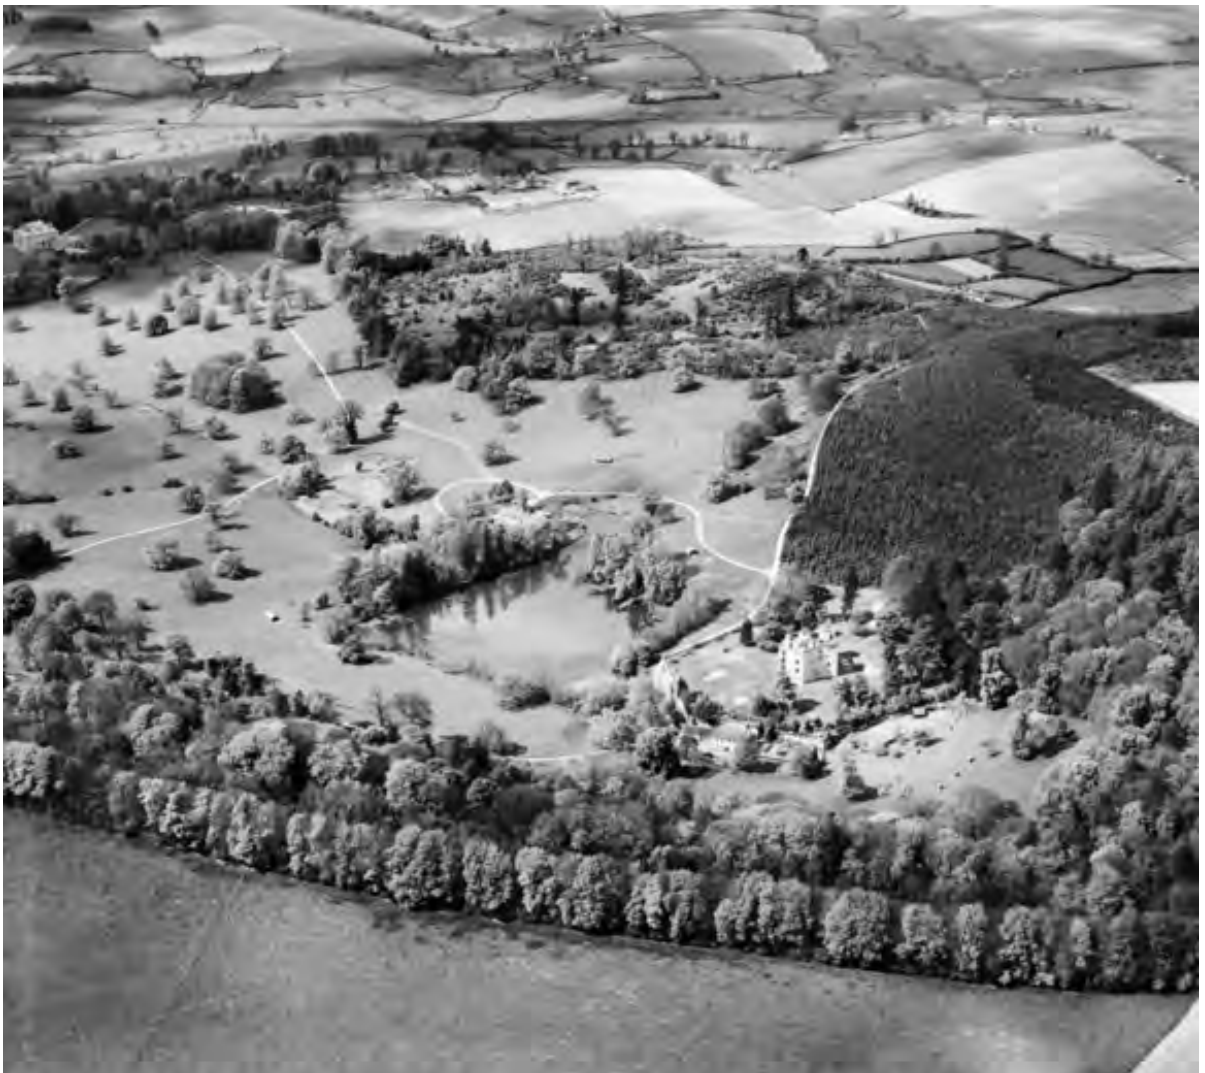
Figure 4.22: The eastern section of the park in 1949. [Britainfromabove.org.uk/image/EAW23179](http://Britainfromabove.org.uk/image/EAW23179). Copyright Historic England.

- 4.108 As late as 1949, the park remained well-treed, as the above aerial photograph shows (Figure 4.22). The hanging woods to the north of the Old Castle had been recently replanted but the mature mix of broadleaves and conifers on the slope above the Old Castle were retained for the time being.

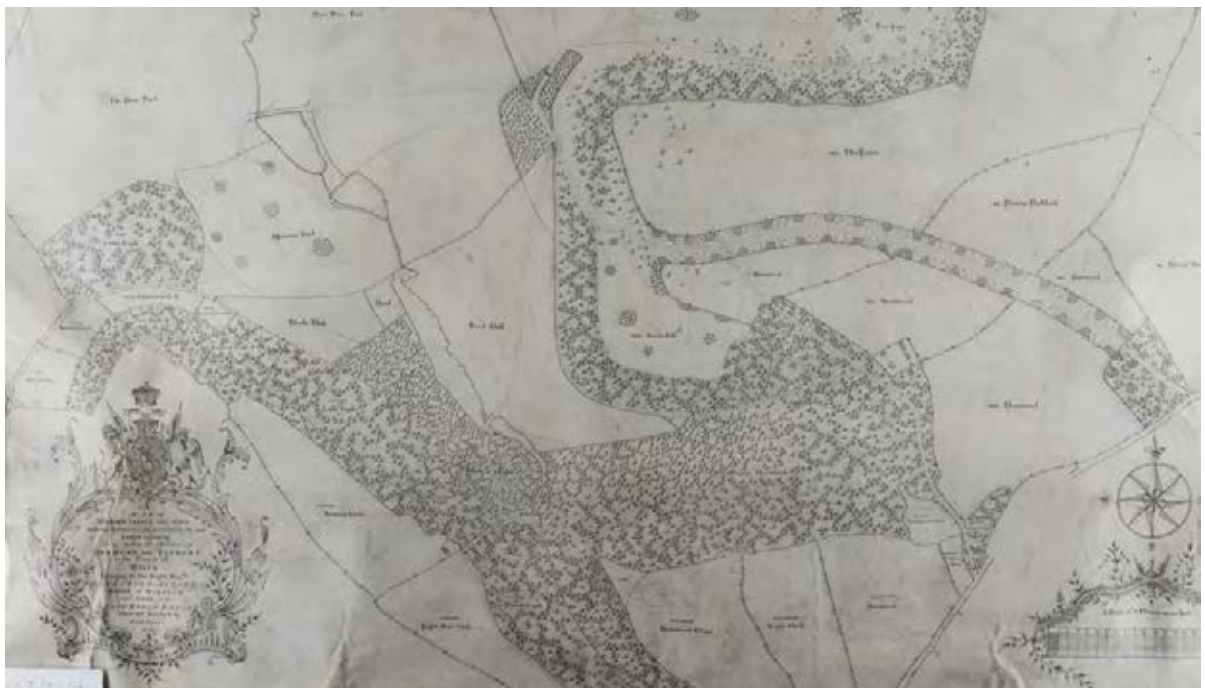
*Ingham survey, 1773 (Wiltshire and Swindon History Centre 2667-21-12H)*

- 5.7 In this character area, as in the majority (but not of all) woodland areas depicted on the Ingham survey, a curious pattern of glades is recorded. It is unclear if the pattern of planting suggested by this motif is an accurate record or merely a surveyor's graphic technique.

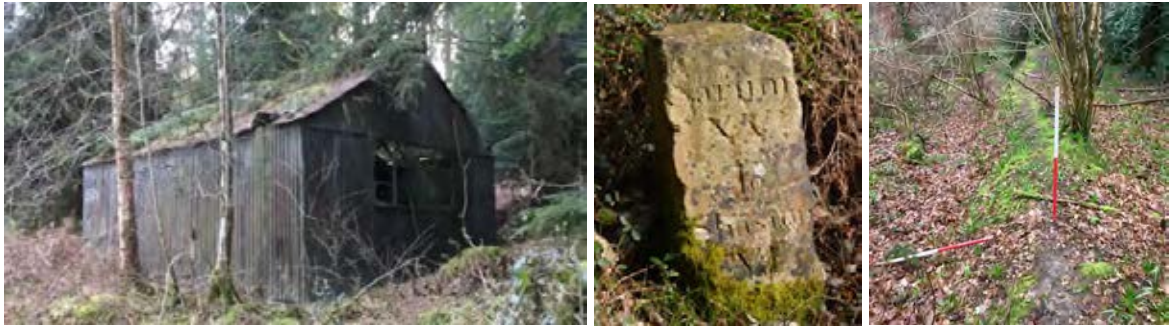
*Boathouse in poor condition (left), milestone (centre) with the inscription ‘Sarum XV to Shaston VI’ – Sarum being Salisbury and Shaston Shaftesbury and boundary bank 15 (right), a surviving section of the park pale.*

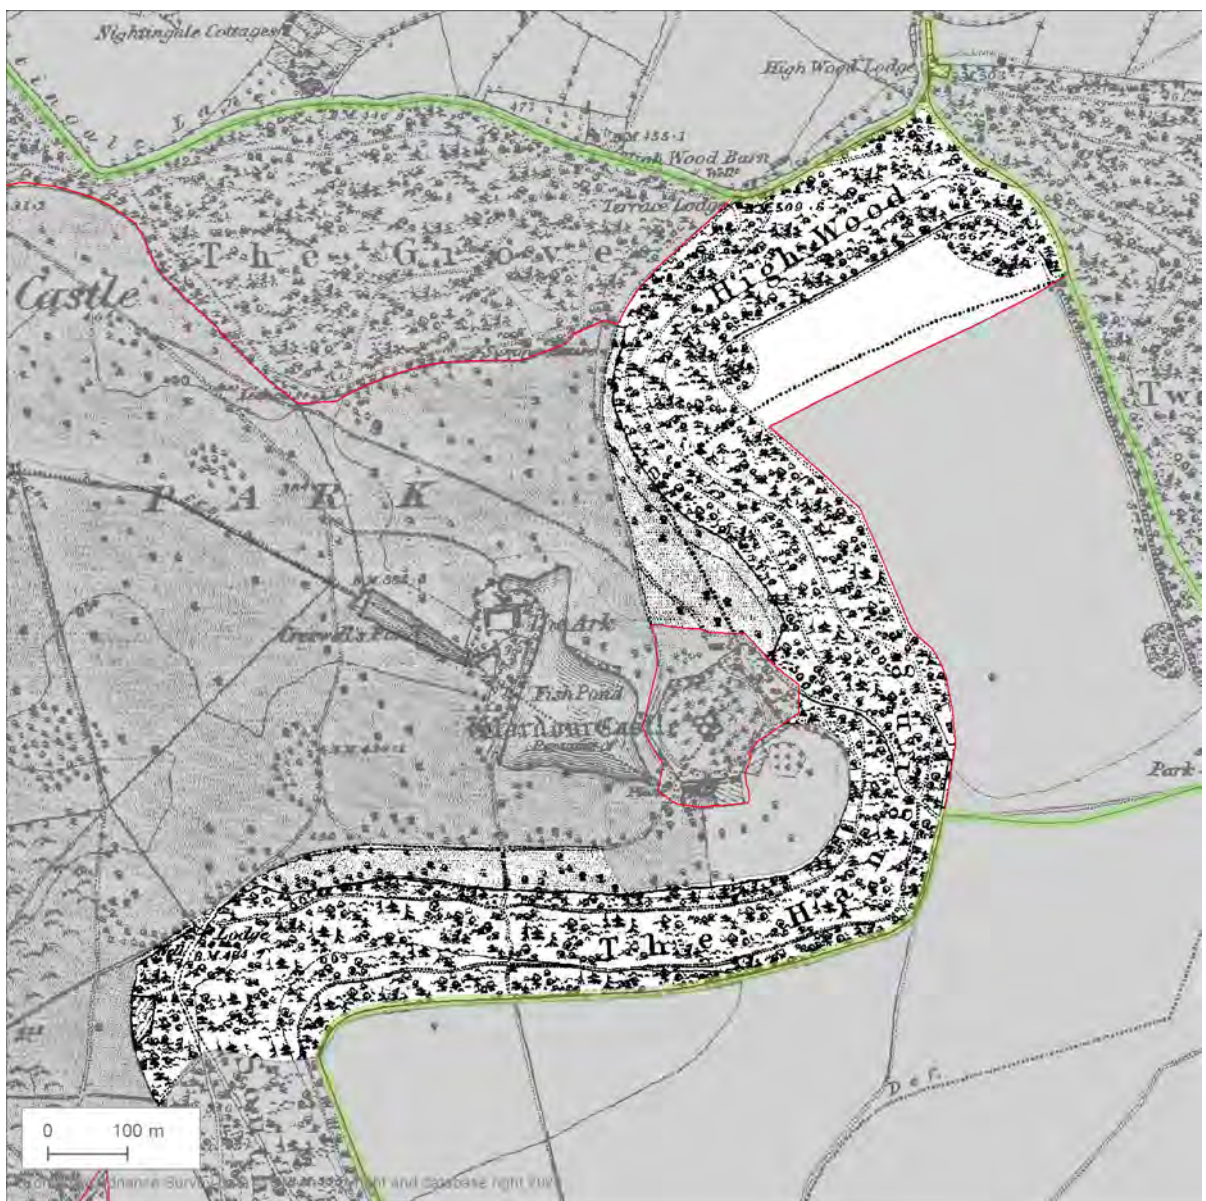
*Extract of the 1890 Ordnance Survey map*

- 5.23 By 1890, Woods' distinctive clump planting along the park-side of the Great Terrace had lost definition, possibly through self-seeded woodland coming in to fill the gap between the clumps. A lodge had been built at the Gothic Archway, known as Trapper's Lodge, and another one at the Horwood entrance (the main entrance from the south).

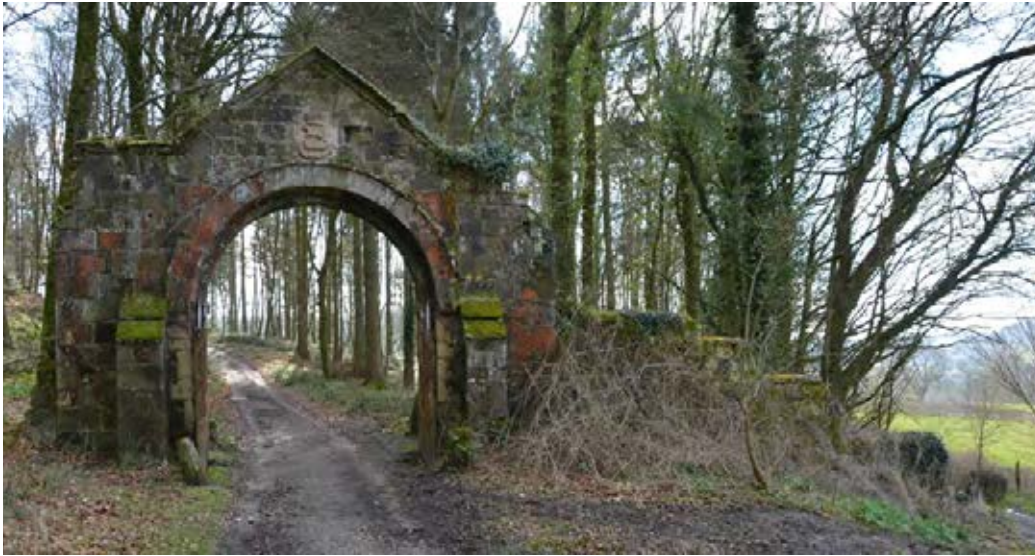
*Trapper's Lodge Arch viewed from the north east.*

- 5.31 Trapper's Lodge Arch was originally part of a larger composition which included the lodge to the south east, and a 8 metre long section of wall on the opposite side stepping down the slope from the archway. The stepped wall remains but the lodge has been demolished, probably before 1980; the bases of the walls of the lodge can be still seen in the undergrowth. Standing on the edge of the woodland, the composition was presumably intended to be seen as a feature within the landscape viewed openin

- 5.32 The principal issue affecting the structure of the archway is that some of the high level stonework cappings have been lost, together with the NW corner of the structure, and that vegetation has been establishing within the core of the high level stonework. The resulting lateral thrust created by the vegetation has further displaced the stonework, opening up a tapered gap on the underside of the arch and causing the stonework to become looser and more vulnerable to further damage by vegetation and by water penetration.

- 5.33 Action is now urgently needed to replace the cappings on top of the archway, to kill off the vegetation and to repair those elements which have now been damaged. Without action the deterioration is likely to accelerate.

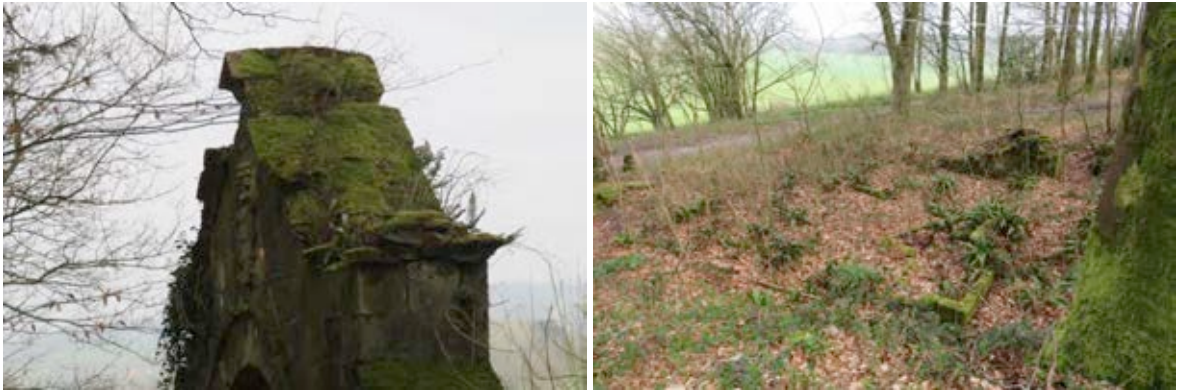
*Archway capping viewed from the south east (left) and the remains of the lodge (right).*

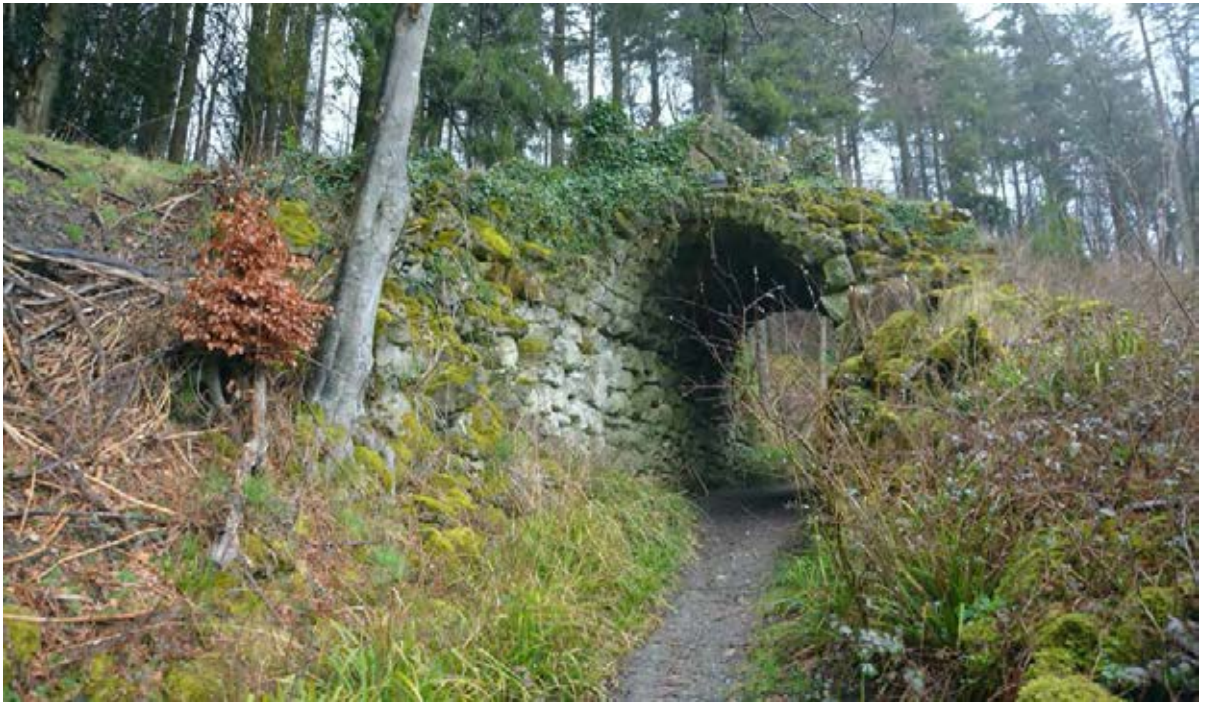
*The Rock Arch viewed from the west.*

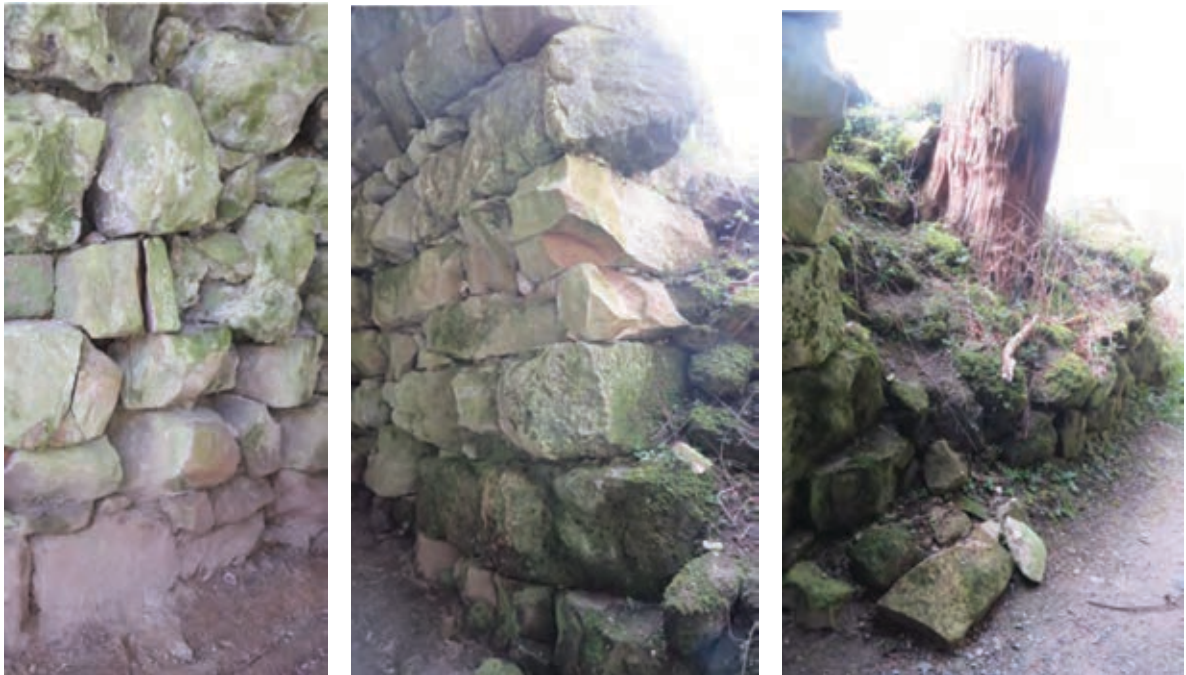
- 5.34 The trackway which rises from Old Wardour Castle to the Hanging sinks steadily below ground level, flanked on each side by retaining walls formed from stacks of rocks; the deepest section is covered by a barrel vault built from much smaller, more regular stones but supported on similar stacks of rocks, creating a tunnel about 10 metres long, 3.2 metres wide and up to about 3.4 metres high.
- 5.35 The barrel vault is formed of narrow stones set in mortar and appears to be in a satisfactory condition. The lines formed in the tunnel floor evidence water penetration through the vault. There is a distinctly muddier colour on the vault in the sections below the pathway which runs over the tunnel. One or two stones forming the vault are now recessed, having lost some material, but no action appears necessary at present.

*Left: a section of the support wall on the south side of the barrel vault – note the series of vertical fractures and some adjacent voids. Centre: the west end of the support wall at the point where it should extend as a wall is now much lower – note the fractures and losses of stonework. Right: a section of the adjoining wall is considerably lower than it must have been originally and is now pushed out by a tree which had been felled by 2011.*

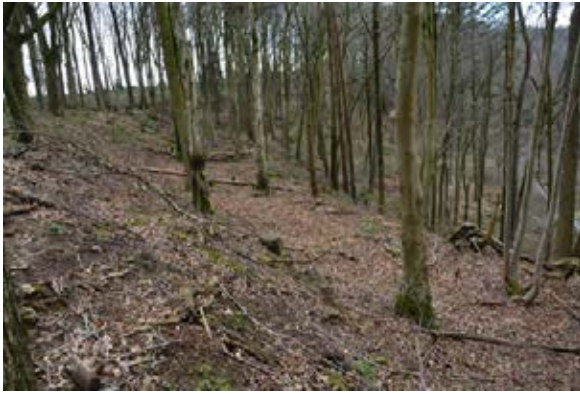
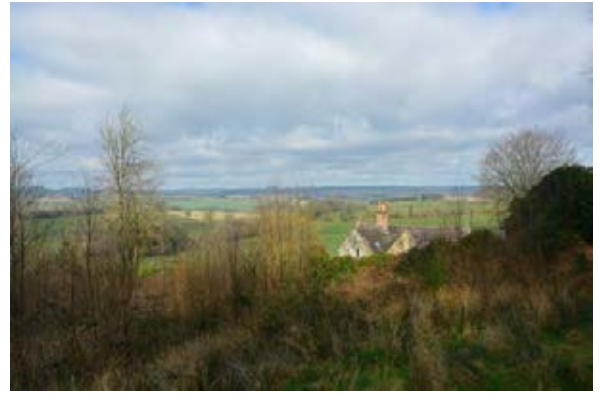
*Left: a section of the upper terrace walk obscured by forestry planting. Right: Panoramic long views from the Great Terrace over Terrace Lodge to the north into the surrounding landscape.*

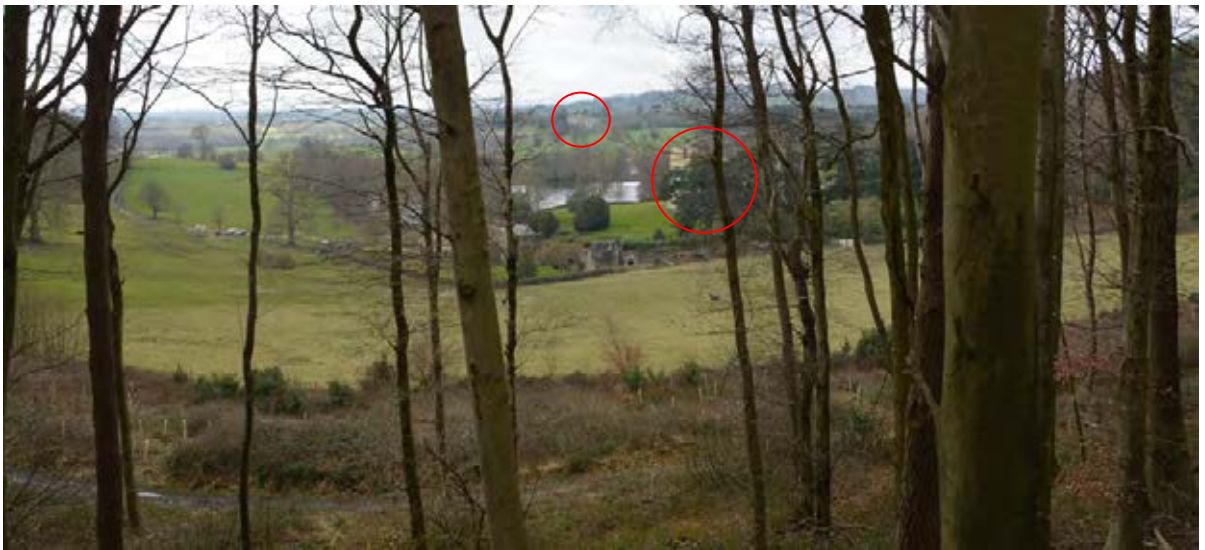
*A view from the upper terrace with the Great Terrace viewed in the foreground. Historically this view would have been more open - the full extent of Swan Pond would be visible and clearer views of Old and New Wardour Castle would be possible (circled in red for clarity).*

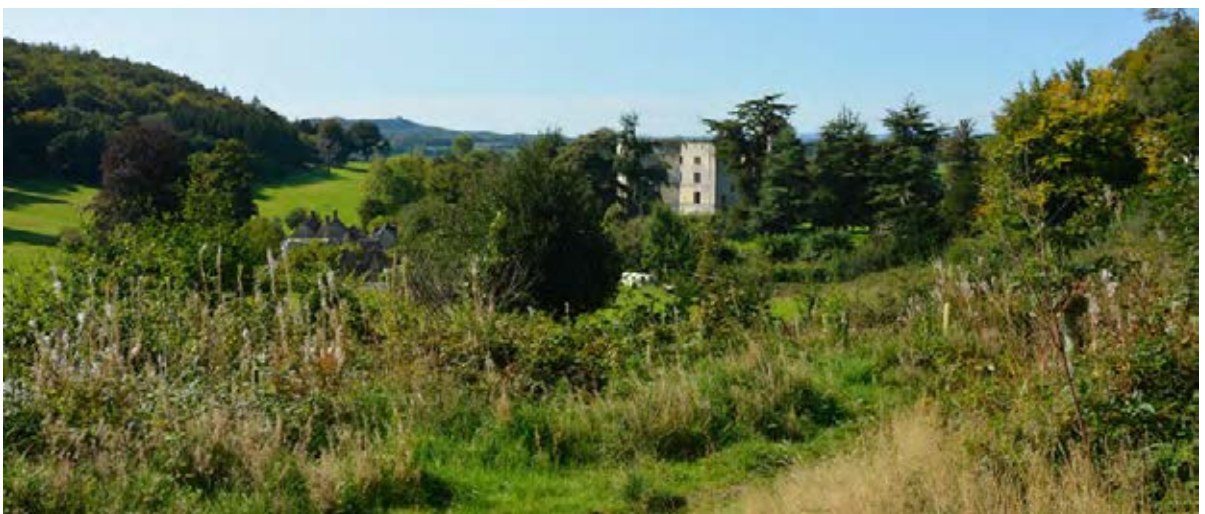
*A view from the Great Terrace looking west with Old Wardour Castle in the foreground. The importance of the wooded escarpment is emphasised in this view with the Hanging framing the left side of the view and Round Hill visible as the wooded hilltop in the distance. New Wardour Castle and Swan Pond should also be visible from the Great Terrace.*

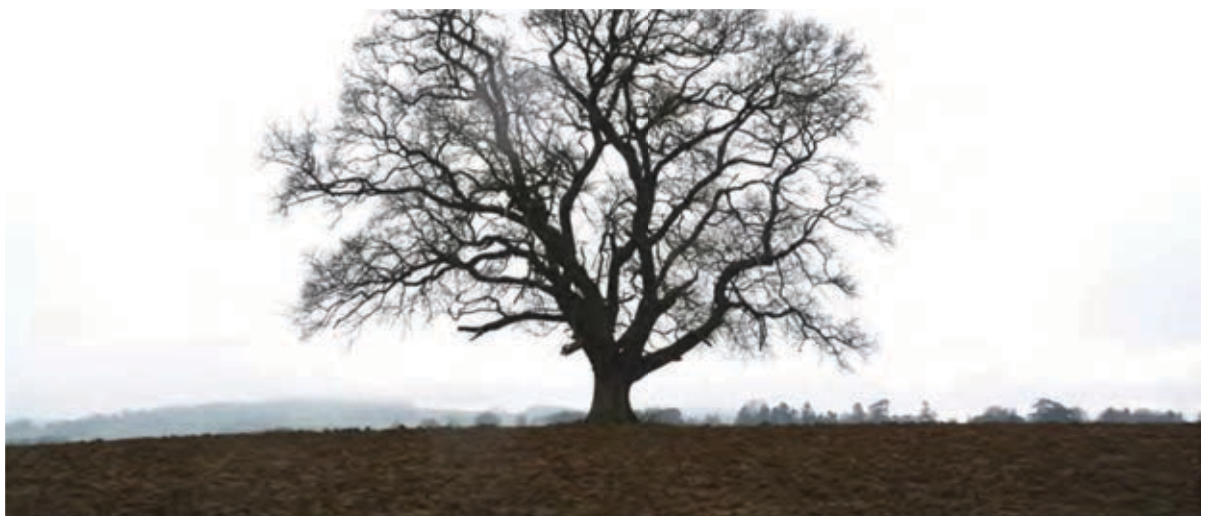
*Ploughing is taking place very close to many trees in the Fallow Deer Park causing damage and threatening the longevity of several specimens in the area including a number of ancient and veteran trees.*

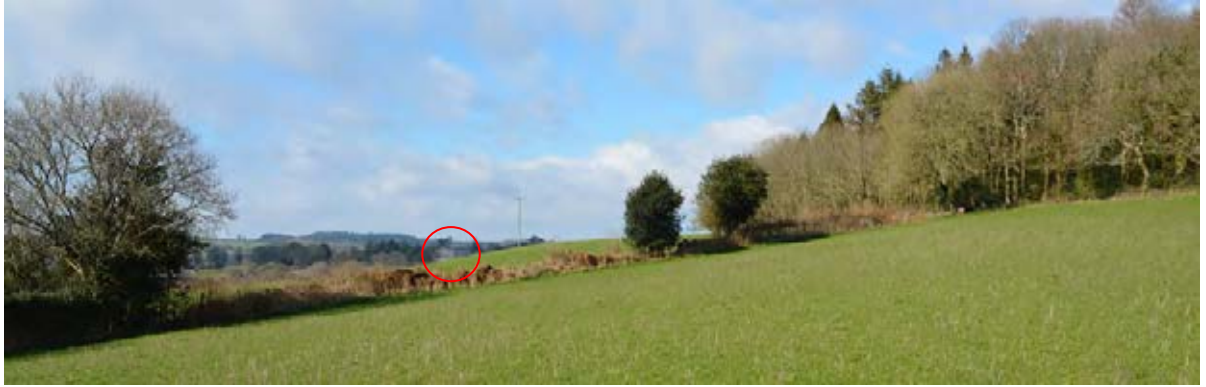
*View from the south near to Pond Close towards Old Wardour Castle (circled in red) in the north across the Fallow Deer Park. Note the presence of overhead electricity cable pole in the view.*

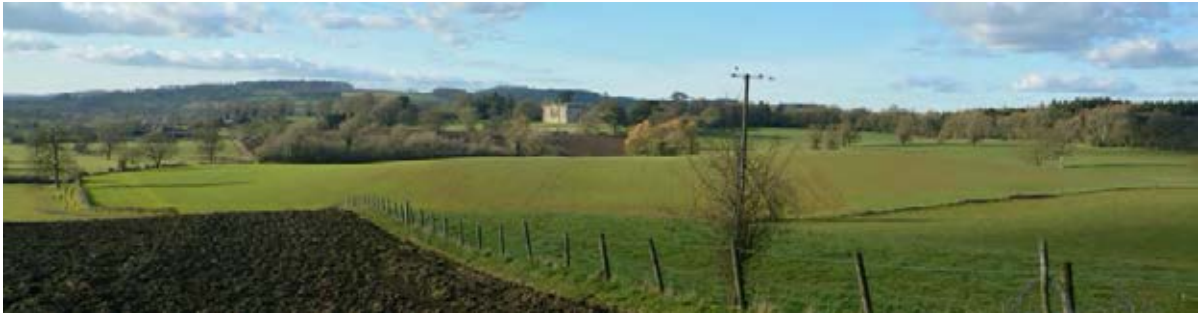
*View from the drive close to Trapper's Lodge Arch looking north west towards New Wardour Castle across the Fallow Deer Park. The newly sown grassland and ploughed land, combined with the electricity pylon and relatively low tree numbers detract from the historic parkland character of the area.*

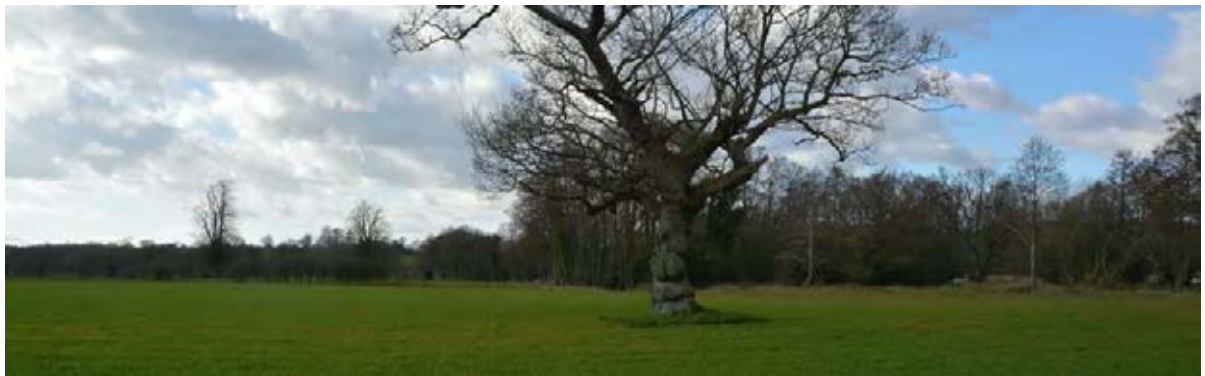
*Ploughing is taking place very close to trees in the Red Deer Park causing damage and threatening the longevity of several specimens in the area including veterans*

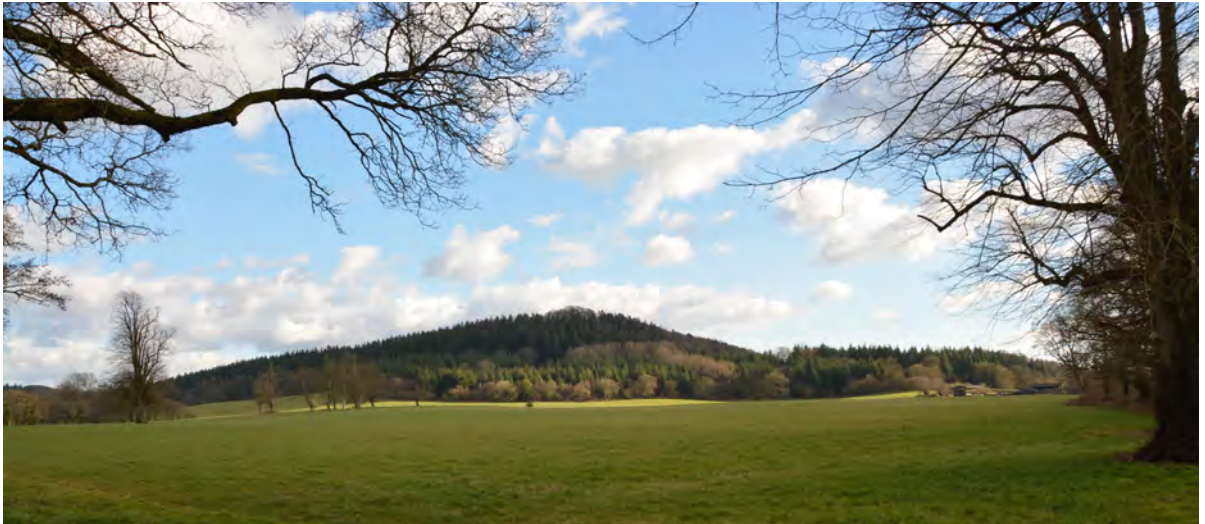
*View from the western end of Park Pond to the south towards Park Copse and the highpoint of Nower's Copse.*
