# Wardour Parkland Plan

*Final Report*

*September 2021*

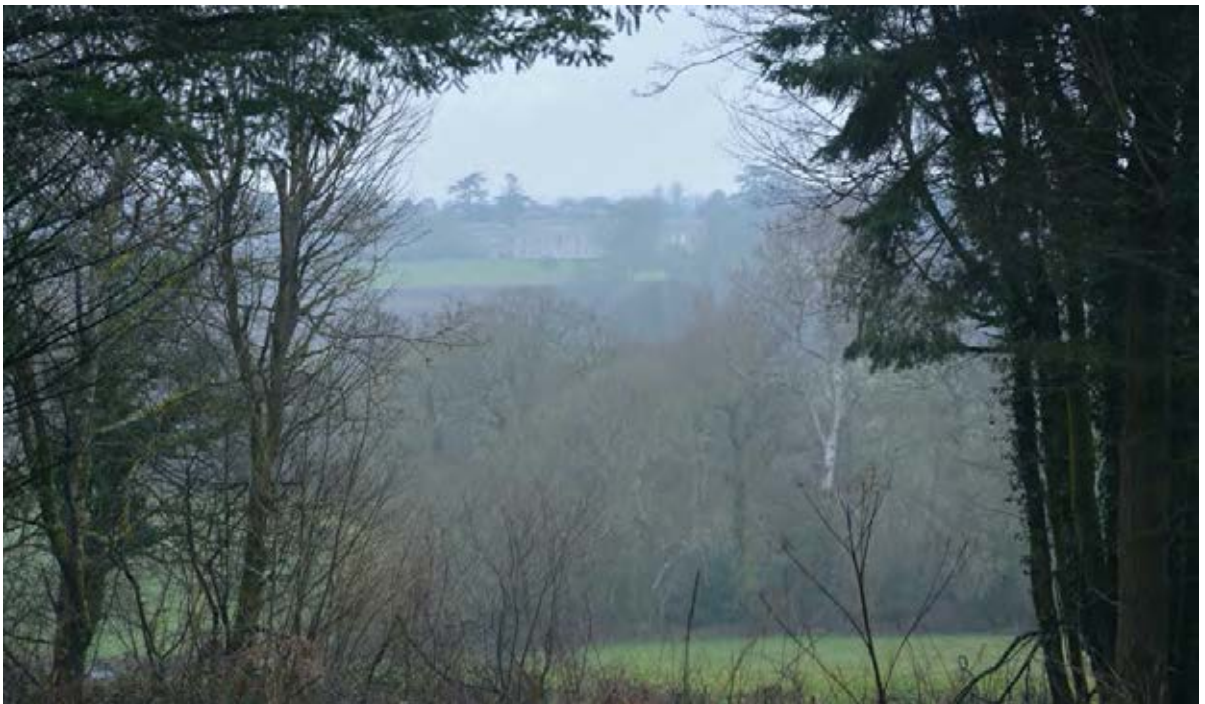
*View from Park Copse to the north to New Wardour Castle using a zoom lens for clarity. Note that the Chain of Ponds at the centre of the photograph is completely obscured from view due to woodland and scrub growth.*

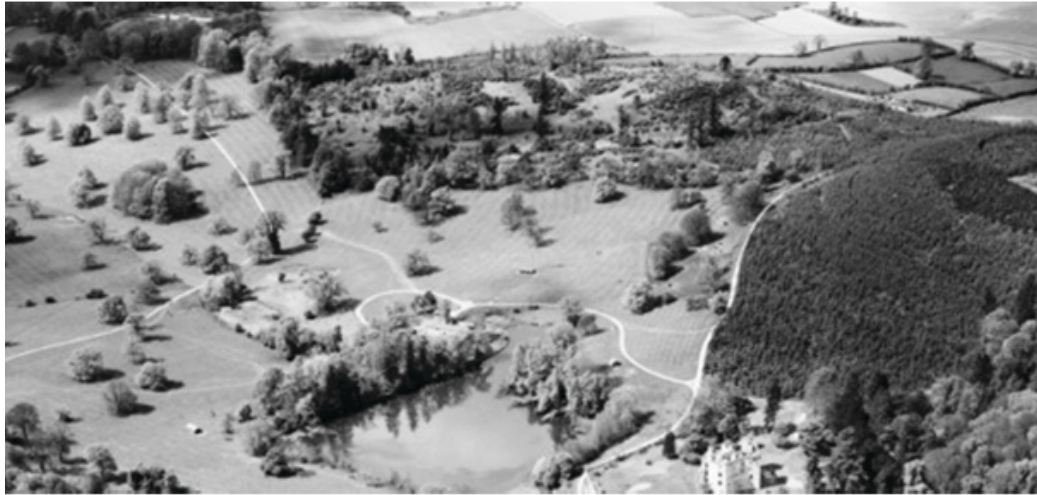
1949 aerial view of the parkland with Old (right) and New Wardour (left) Castles circled in red. [Britainfromabove.org.uk/image/EAW23179](http://Britainfromabove.org.uk/image/EAW23179). Copyright Historic England.

- 5.94 This character area continued to be managed as parkland and, as late as 1949, was well treed. Since 1949, the loss of parkland trees has accelerated and probably three quarters of those present in 1949 have been lost

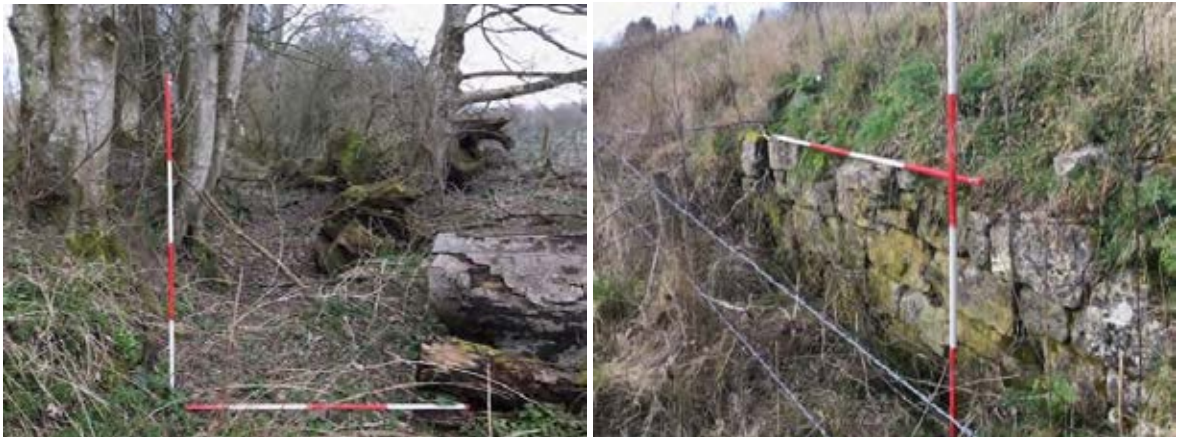
- 5.95 The ha-ha (003) was a major feature that defined the boundary between park and garden. It consisted of a dry ditch up to 7m wide and 2.5m deep with a stone wall originally lining it on the house side. Its condition is poor and has, in places, been partially filled in and subject to dumping of unwanted building materials.
- 5.96 The east end survives as a deep overgrown ditch with occasional traces of stonework) and the outer scarp had been quite badly disturbed by badger setts. Tree and scrub growth is evident along much of the feature and has caused considerable disturbance and continue to pose a threat to the feature.

Views of the ha-ha taken during the archaeological survey. Left: the ha-ha south east of New Wardour Castle, looking north east. Right: the ha-ha with a surviving section of stone facing to the south west of the New Wardour Castle, looking north west.

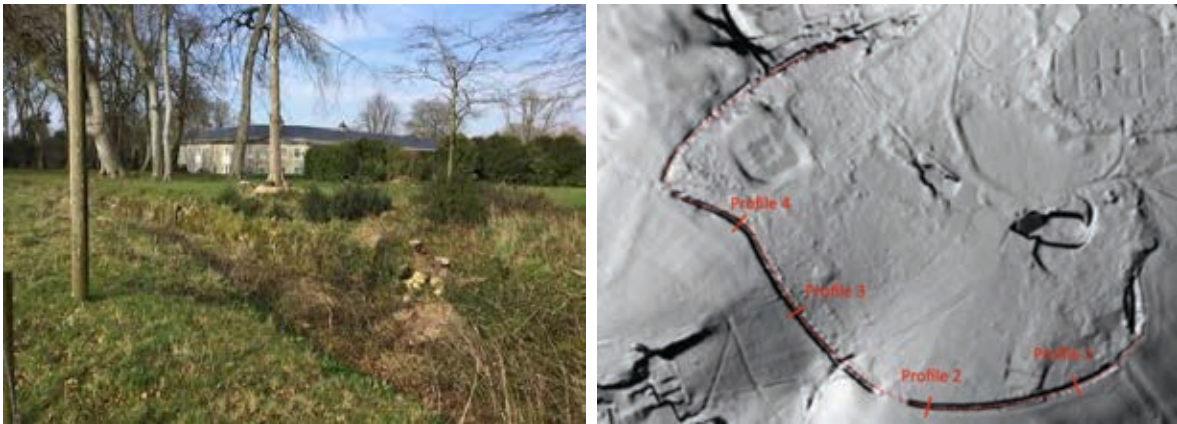
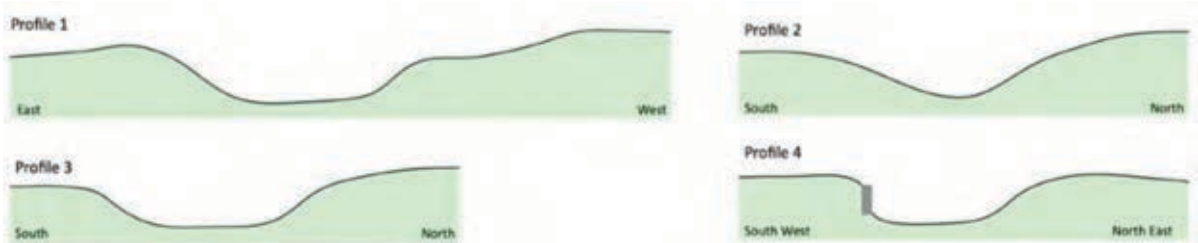
Details of the ha-ha taken during the archaeological survey. Top left: the ha-ha west of New Wardour Castle looking to the north east. Top right: LiDAR imagery of the ha-ha showing the location of surveyed profiles. Bottom: profiles of the ha-ha at four locations to demonstrate the varied survival and condition of the ha-ha.

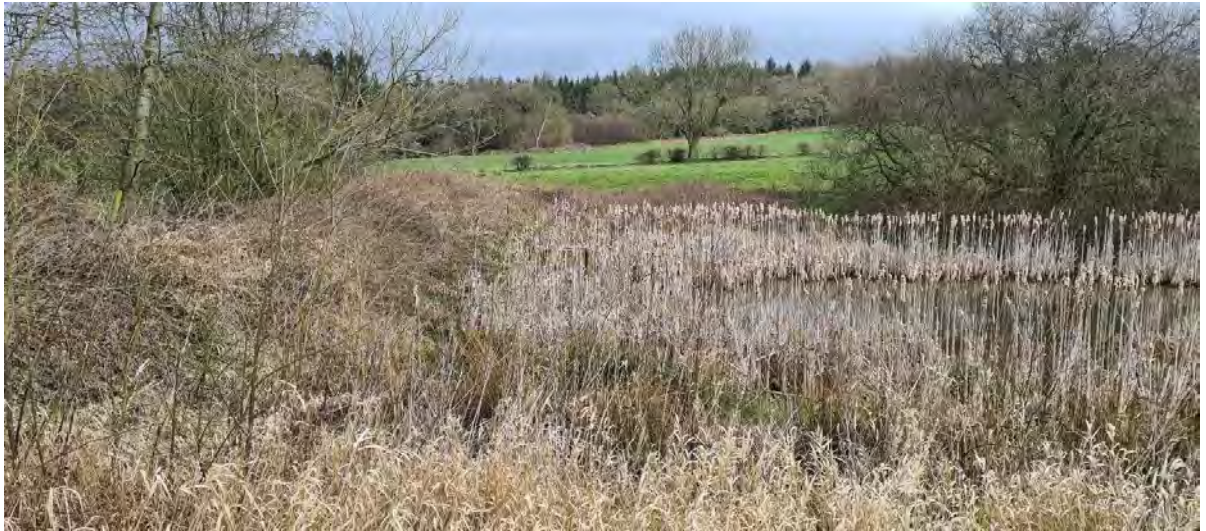
*Creswell's Pond embankment. Low water level and extensive vegetation both reedbeds and woody scrub/trees*

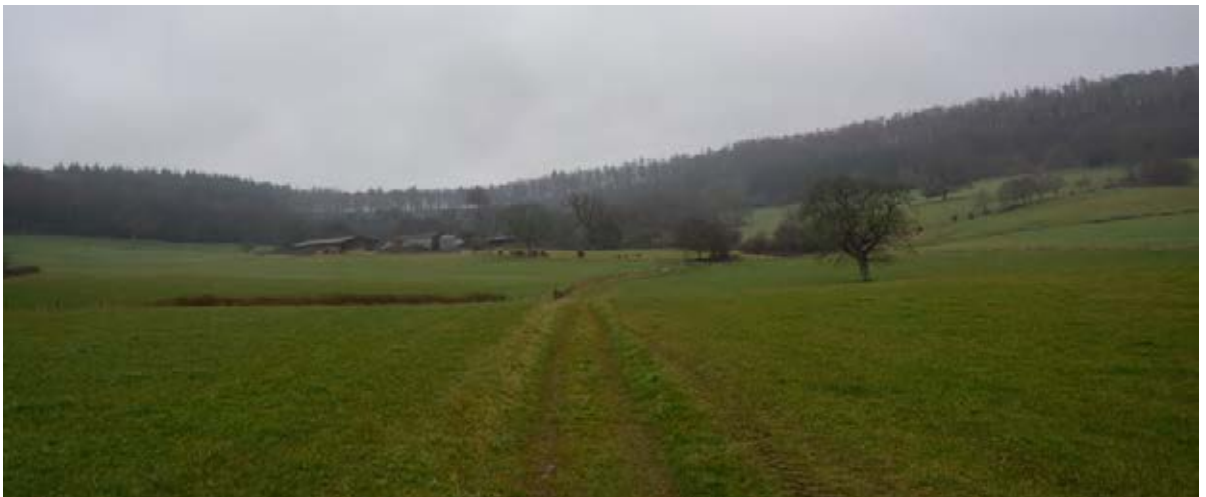
*View from the historic driveway looking east towards Ark Farm with the modern farm buildings in the middle ground. The wooded escarpment provides the backdrop to the parkland which historically possessed a far greater number of trees.*

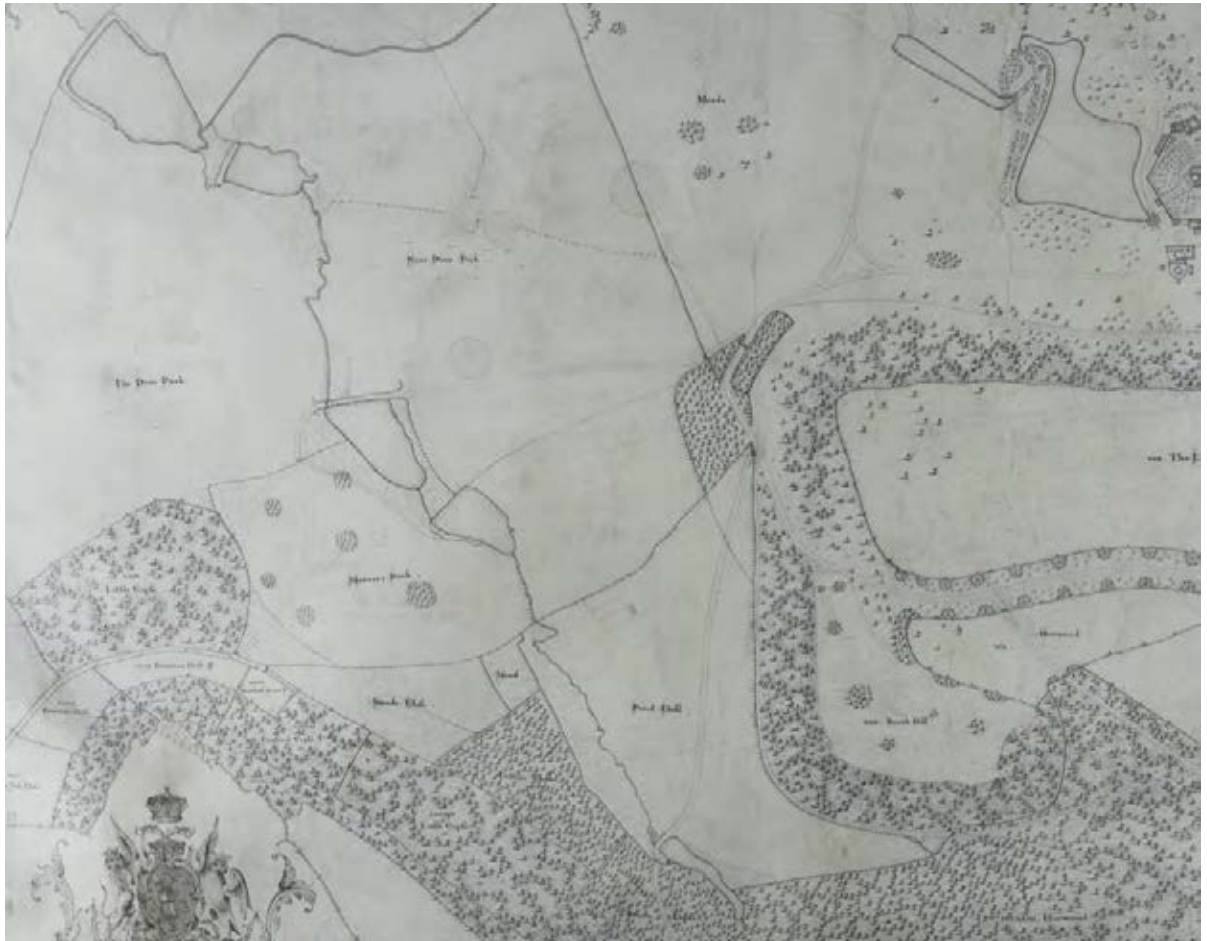
*Extract from the 1773 Survey showing the chain of ponds (Wiltshire and Swindon History Centre 2667-21-12H)*

- 5.121 The 1773 Ingham survey shows a similar layout to the 1753 survey, with the exception of Horwood Pond which is shown as more elongated. It is likely that Woods added cascades to some of the ponds. The dams between Park Pond and Island Pond, and between Heron Pond and Park Pale Pond, were utilised to carry tracks, possibly new approaches across the park, which would have allowed a glimpse of water and views of the New Castle.

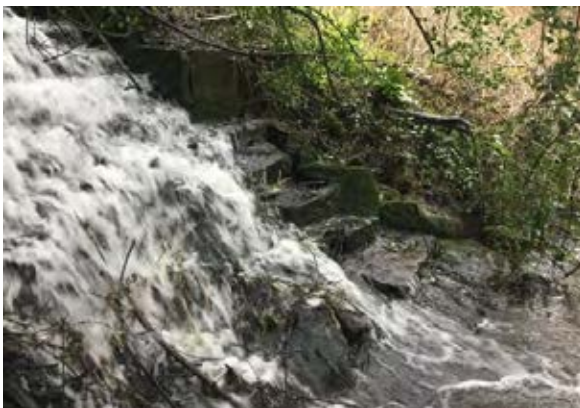
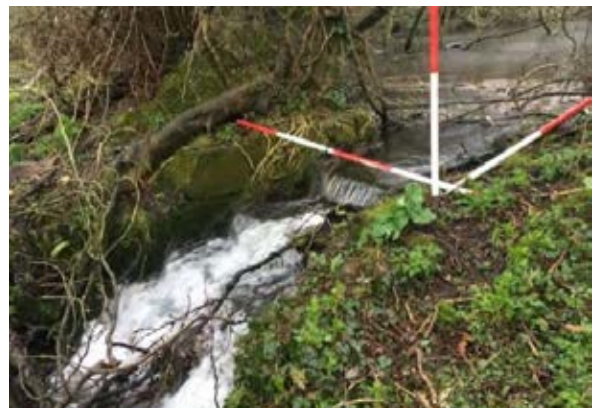
Left: cascade 018 from Park Pond looking north west. Right: cascade from Island Pond 019 looking north.

- 5.124 There are constructed outlets to each of the ponds including two cascades to Park Pond and Island Pond (018 & 019), two outfalls to Heron Pond and Pale Park Pond (021 & 022) and a conduit to Horwood Pond (024), which are illustrated below.

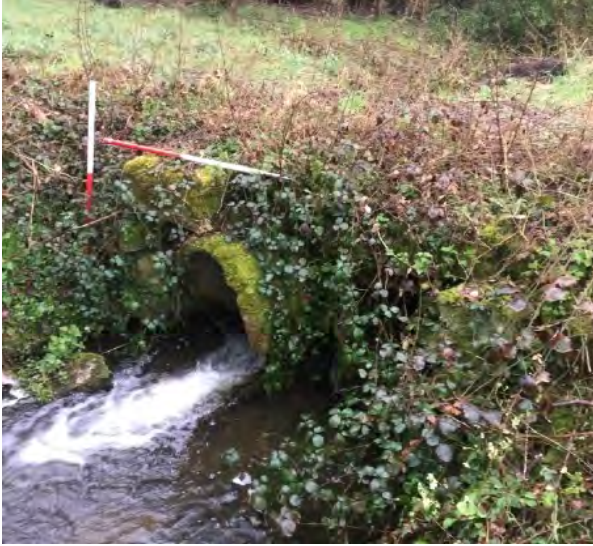
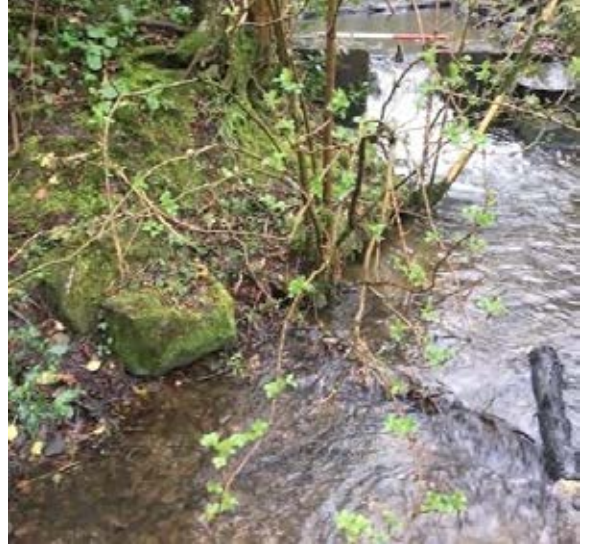
*Left: bridge between Heron and Island Ponds 020 looking south east. Right: cascade and spillway to Heron Pond looking south east (021).*

5.125 A bridge structure was recorded between Heron and Island Ponds (020). Additional details of these and additional structures are included under hydrology below.

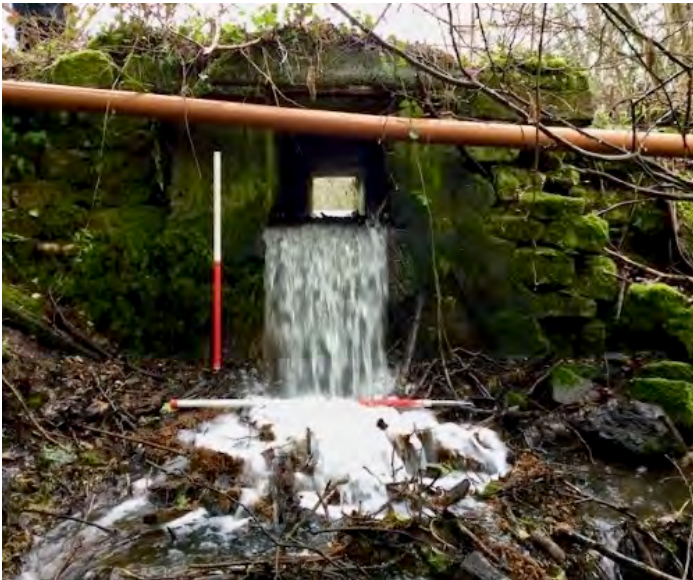
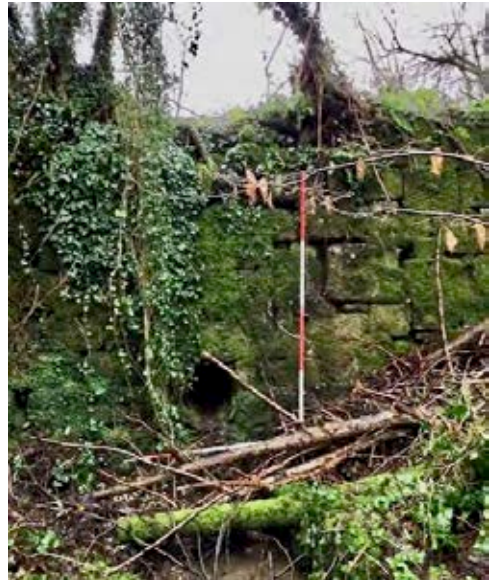
*Left: outfall to Pale Park Pond 022 looking south east. Right: retaining wall 023 to Pale Park Pond looking south east.*

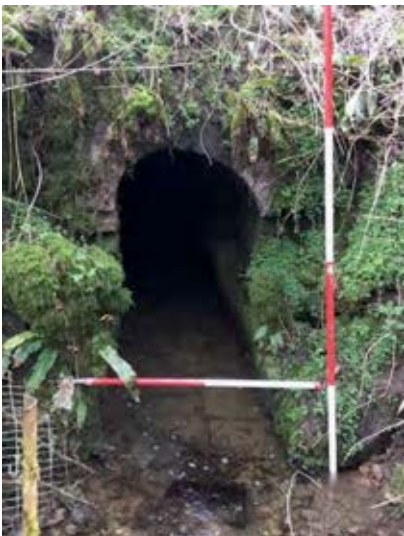
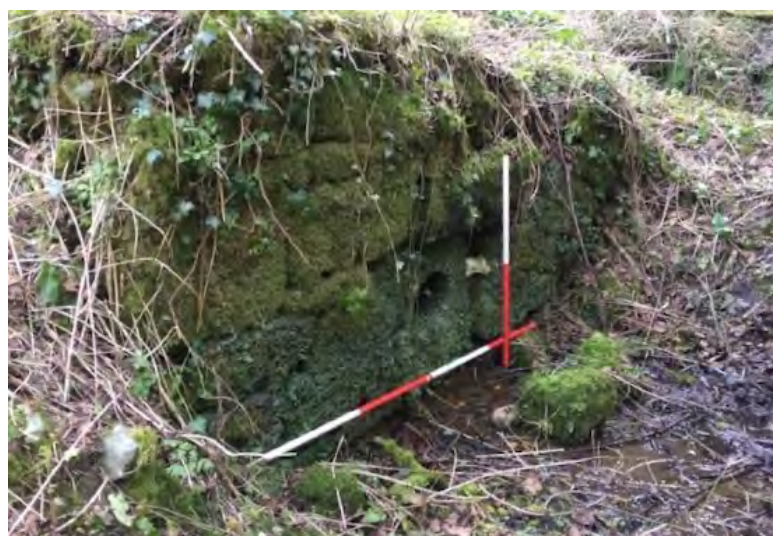
*Left: conduit 024 to Horwood Pond looking south east. Right: retaining wall to Horwood Pond looking west.*

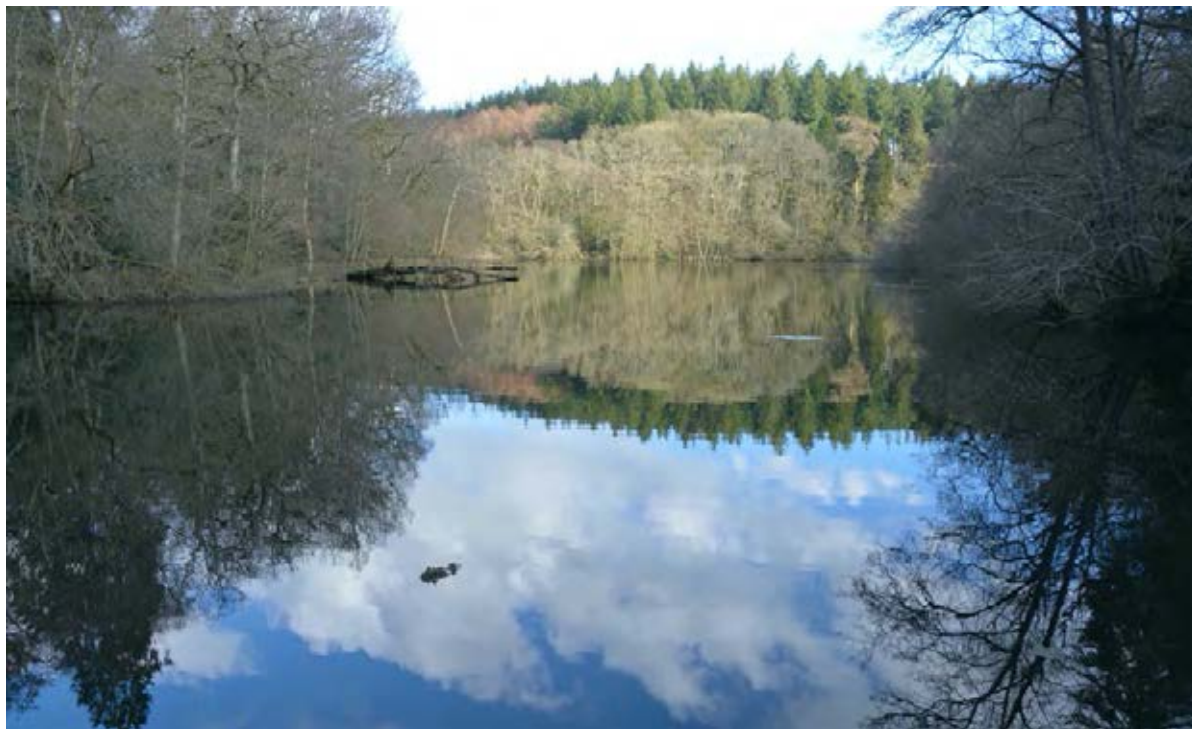
*View of Horwood Pond from the north west on the dam.*

- 5.135 When compared with the 1887 OS 1:25 inch map the total water surface of Horwood Pond appears not to have changed a great deal, with the exception of the two upstream arms, which are each supplied by separate sub-catchments. Therefore, the loss of the historic water surface is likely to be due to vegetation succession rather than a lowering of the water level.

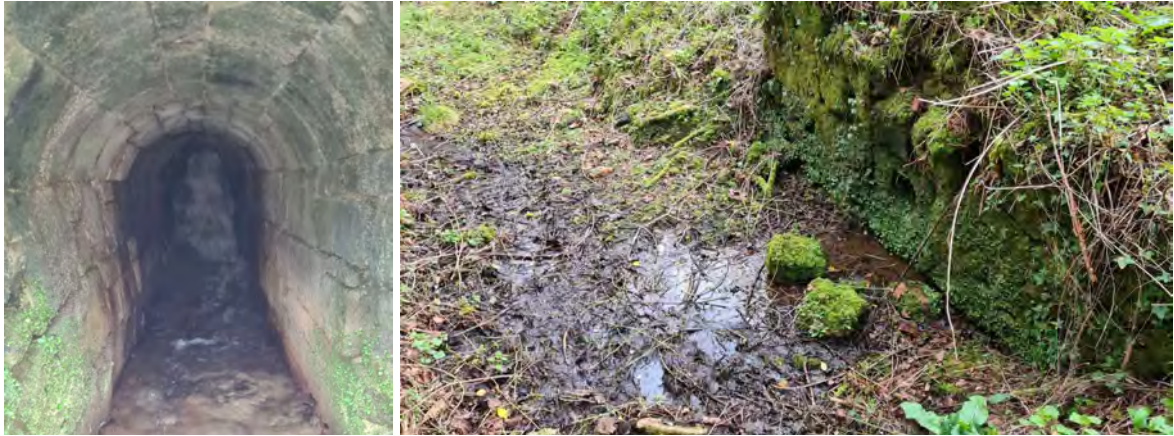
*Left: the culvert in the dam is in reasonable condition, but traffic over the dam should be restricted and the bulging wall monitored or repaired. Right: Lake seepage through the dam in and around the scour outlet head wall.*

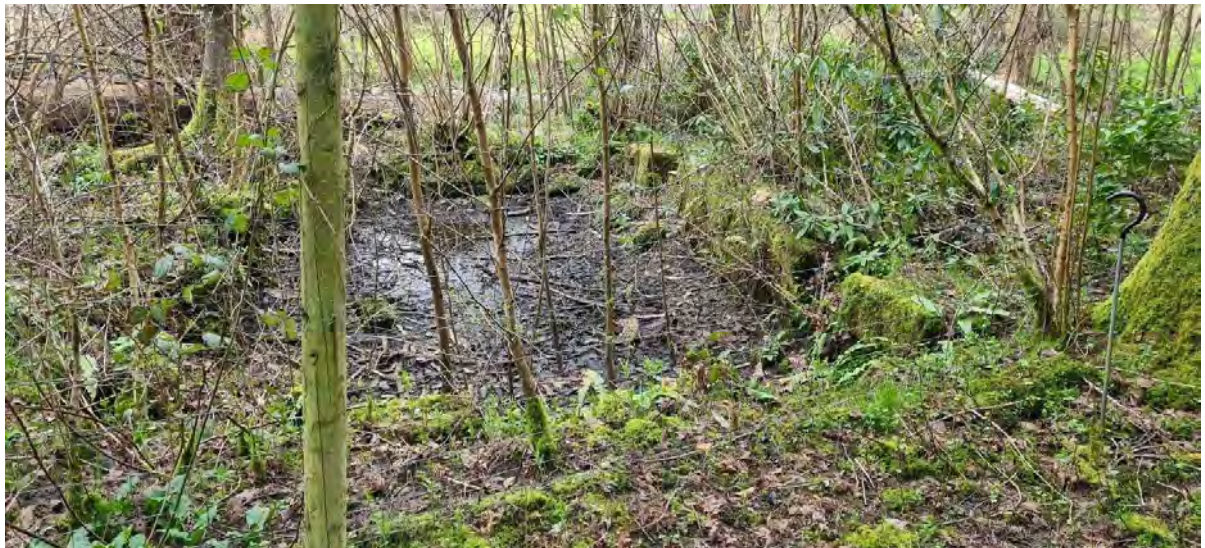
*Stone rectangular pond behind stock fence which encloses the Pond Close site*

5.141 The rectangular structure appears to be constructed of local stone and is approximately 5.5m long by 2.75m wide with an unknown depth. It is not shown on modern surveys but lies within or close to the original valley invert and was fed, at least in 1887 by the stream from the Horwood Pond upslope. The stream's route has been changed since the pond was last in use, but the old channel is still visible. This pond's function is unknown; however, it could be part of an eel trap, a sheep dip, a watering place for livestock, or for the kennels which were previously sited close by.

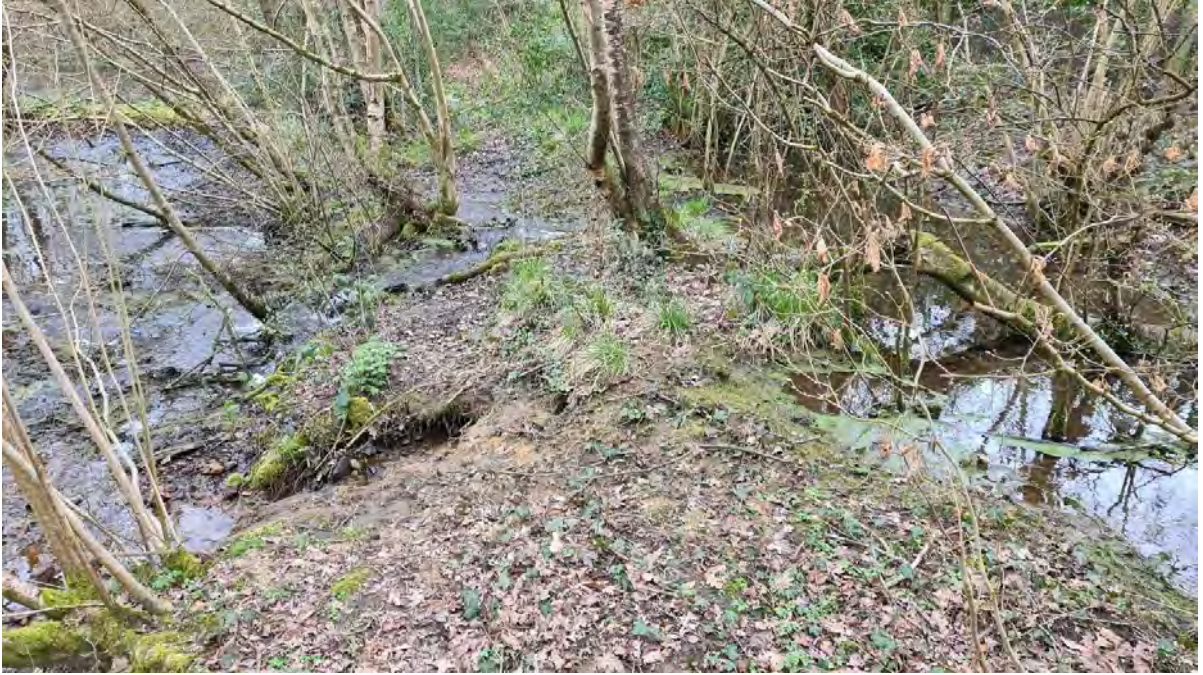
*The impounding structure of Close Pond with the immediate upstream part of the Pale Park Pond to the left. Multiple leaks and evidence of regular over-topping.*

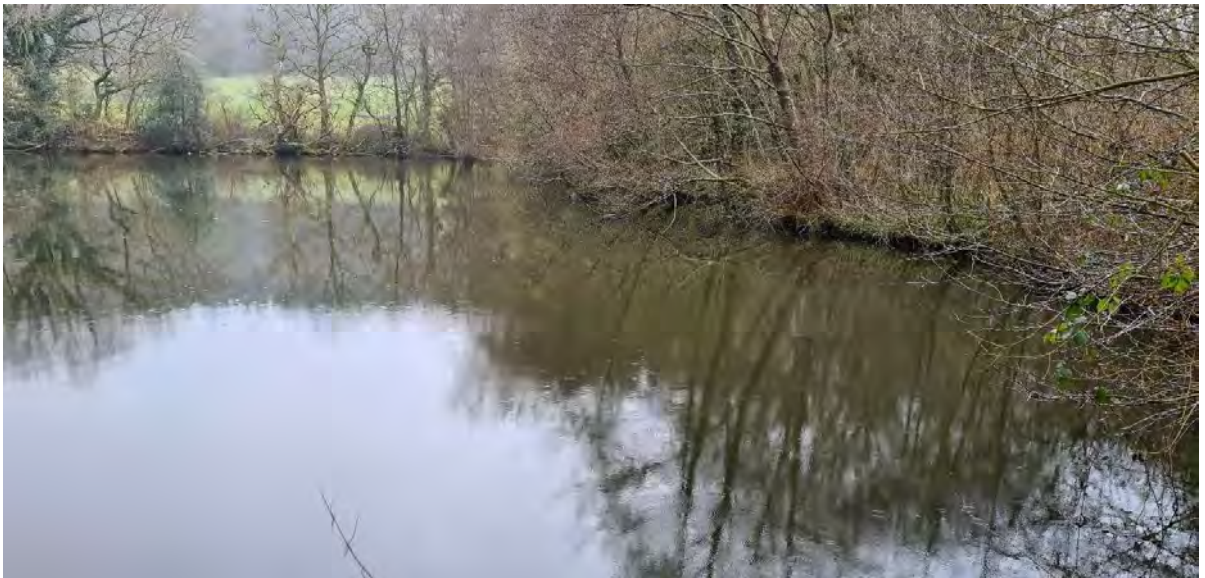
*Pale Park Pond appears to have a high water level.*

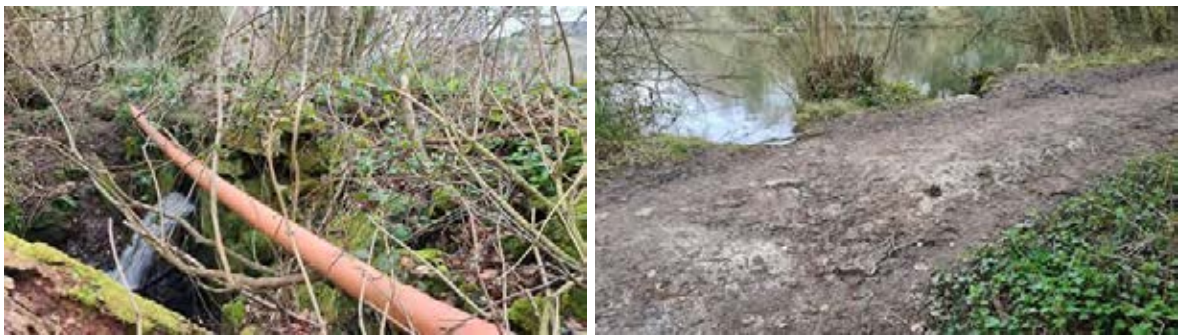
*Left: the outfall (the flowing water) of Pale Park Pond is too high and/or too small. Right: evidence of overtopping on Pale Park Pond Dam.*

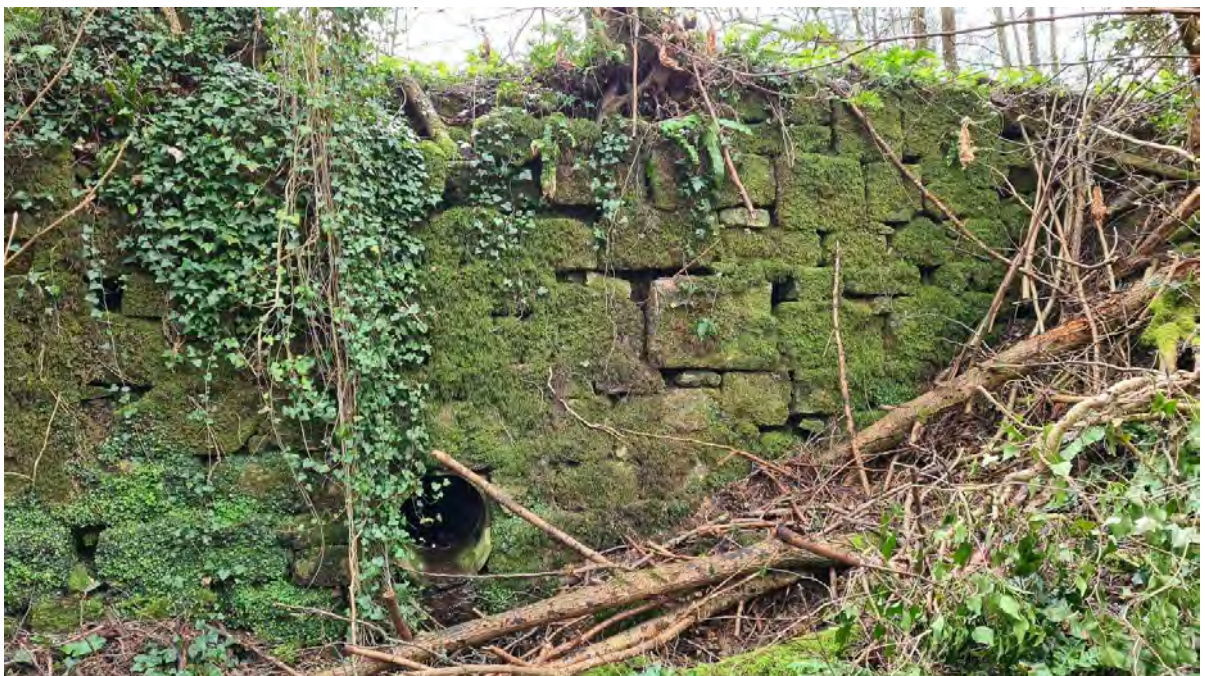
*Scour outlet headwall at Pale Park Pond has moved, most likely due to root heave.*

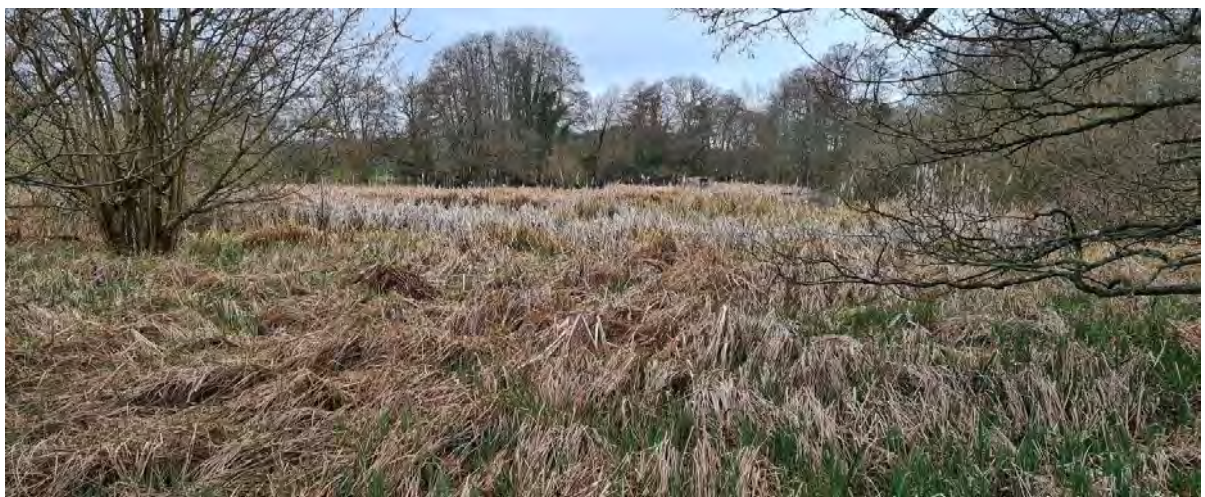
*View of the extensive reed-bed in the south east corner of Island Pond looking north west.*

- 5.158 The pond is heavily silted and could be dredged, with an estimated 4000 tonnes of silt requiring removal, however, ecological considerations might determine that the reed beds and carr should be retained and managed as found.
- 5.159 The banks and dam are heavily wooded and over-topping and leakage is evident in many places. Irrespective of the final management plan determined for this pond, the trees on the dam should be removed and the leakage addressed. Evidence of badgers or rabbits were seen in the dam structure.

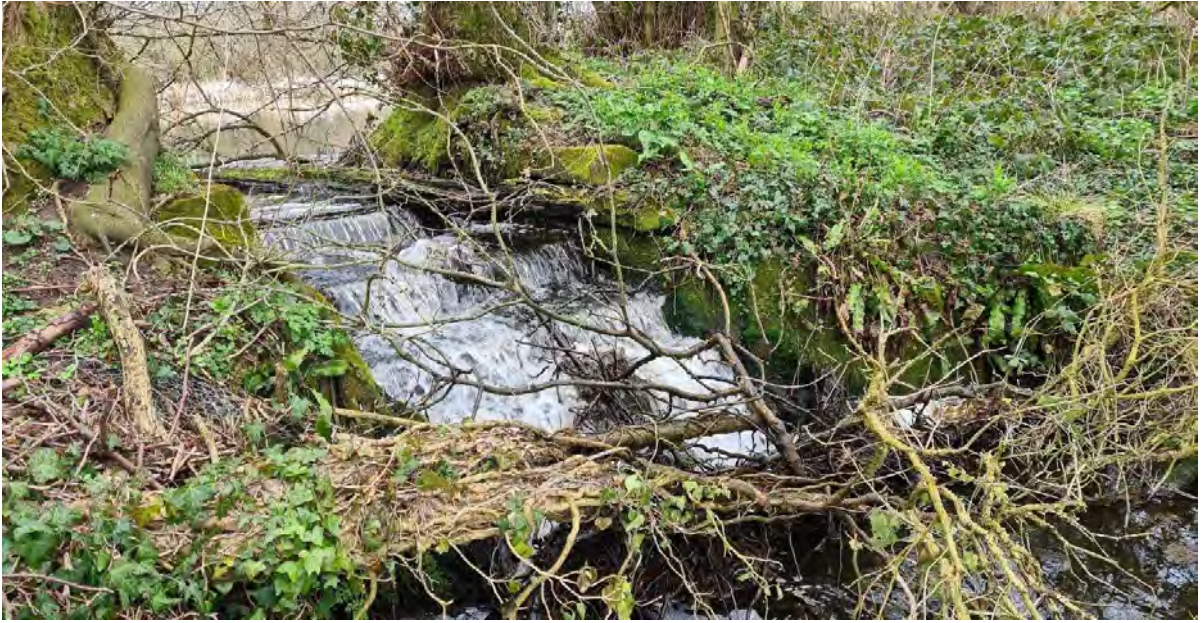
*The cascade to Island Pond is functional but leaking.*

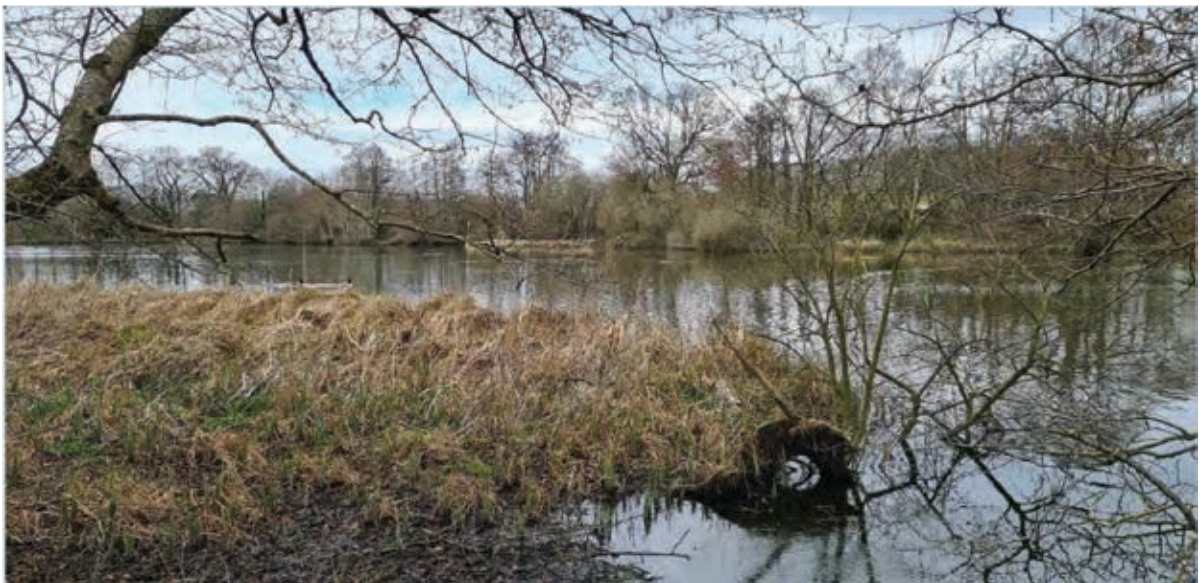
*Park Pond with reed-beds in the foreground.*

- 5.163 The present shape of the pond, all be it with marginal encroachment is well-defined and appears to be similar to the 1887 OS map, which, it is also presumed, is close to the design plan.

- 5.165 The water level seems to be correct, or possibly marginally high, and there is clear evidence of over-topping in places. This is probably caused by blockage of the main outfall in the east owing to lack of monitoring or maintenance. Elsewhere there are holes in the bank caused by rodents or tree roots. All such 'holes' require inspection and possible repair. Following tree removal on the dam structure, this may result in extensive sheet-piling being recommended.

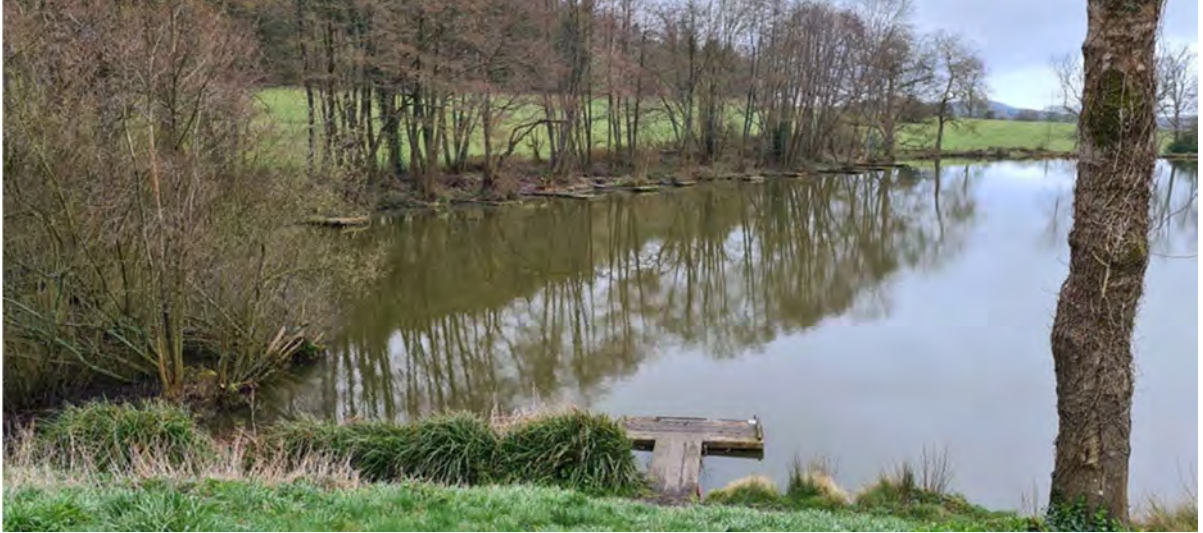
*Alder trees have encroached the southern edge of Swan Pond.*

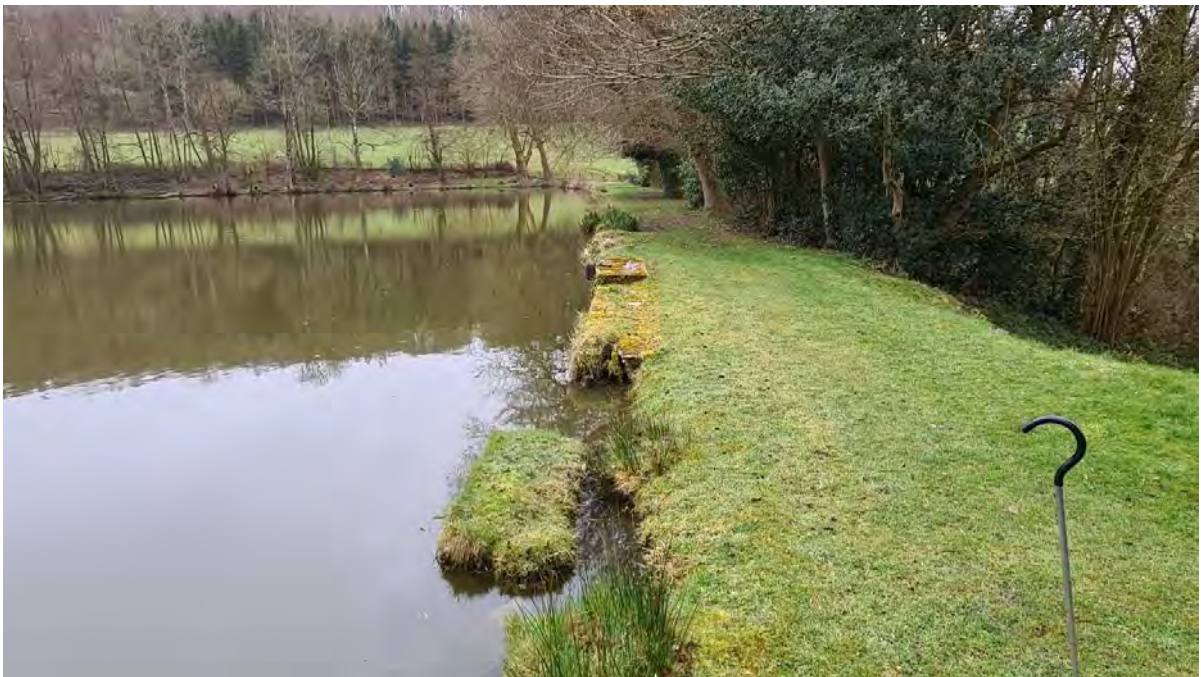
*The collapsed and slipping dam wall stonework viewed from the north.*

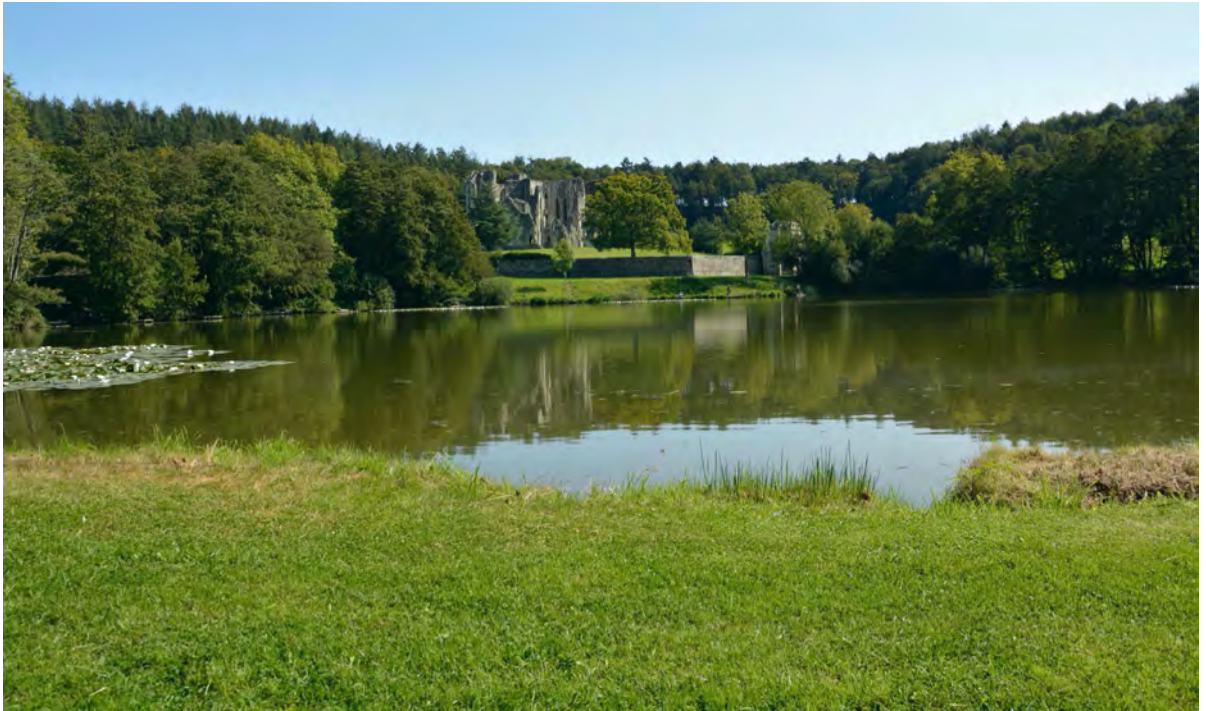
*Exceptional views are gained from the west looking over the open water towards Old Wardour Castle demonstrating the water's reflective quality. The self-sown tree groups either side of the pond detract from the historic character and quality of picturesque view – upsetting the balance of open space in the middle ground.*

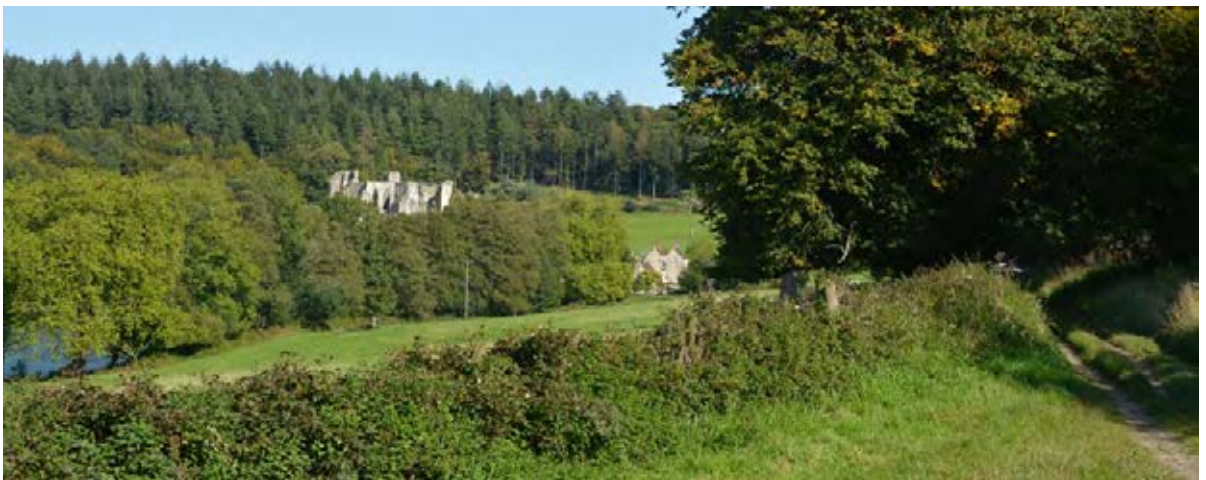
*View of Old Wardour Castle from the historic approach drive looking east. The open water of Swan Pond can be glimpsed in the bottom left and the intrusive alder tree group lies in the middle ground, preventing the intended picturesque composition of open water and castle ruins in front of the wooded escarpment.*

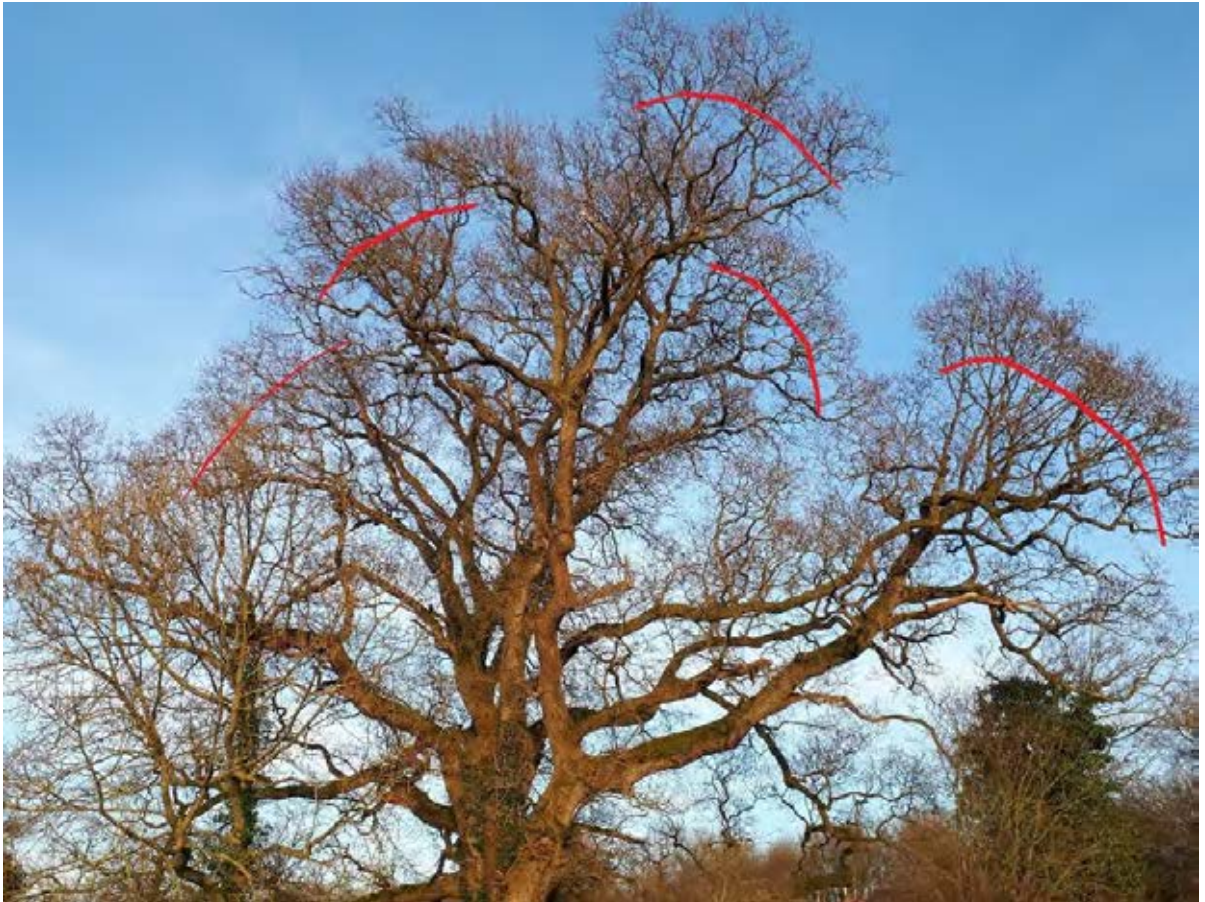
*First phase of crown reduction works indicated by red lines*

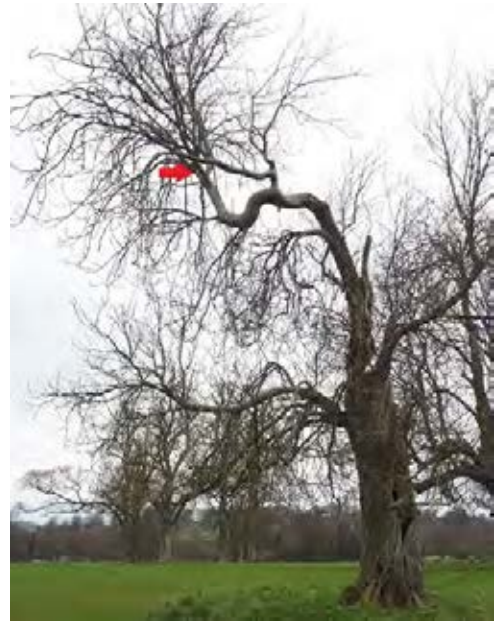
*Crown reduction to T 42 indicated by red arrow*

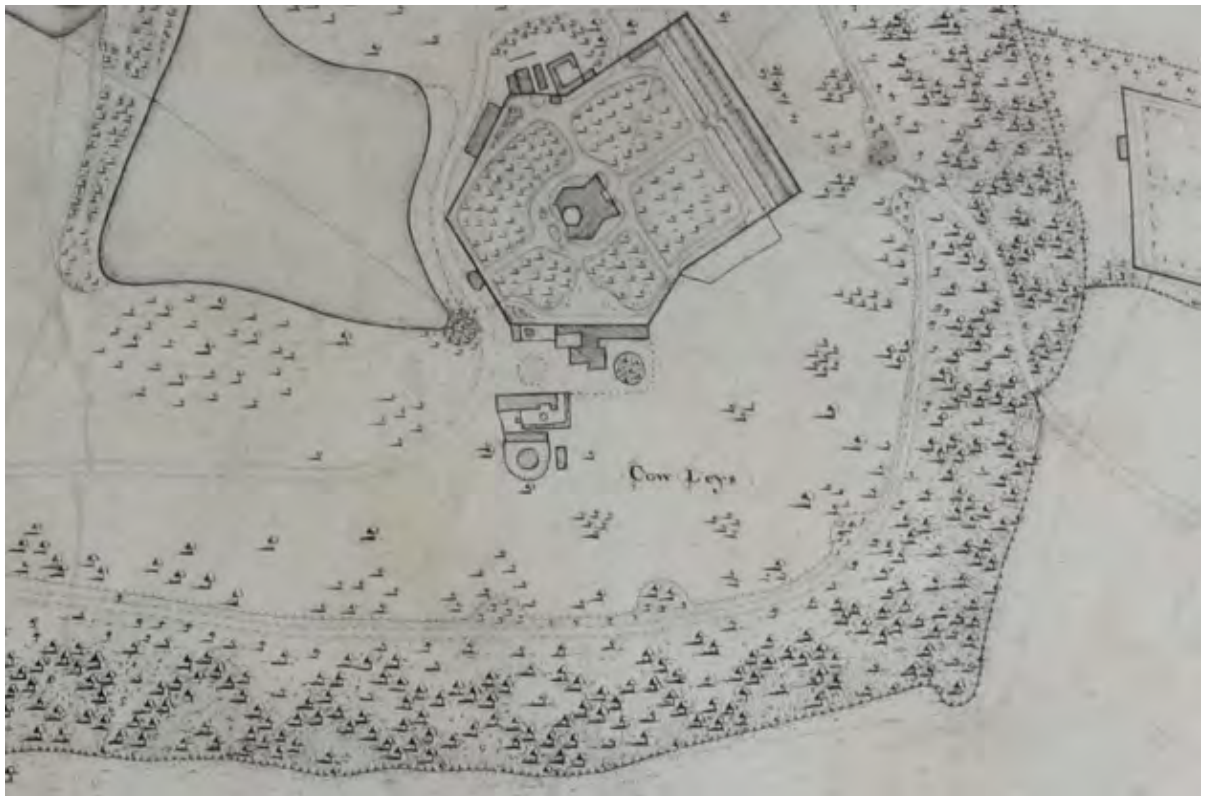
*Extract of the Ingman survey dated 1773 showing a combination of clumps and scalloped edges below the Great Terrace affording views to the Old Castle, Swan Pond and to the parkland beyond.*

- 8.38 Historic woodland compartments 13 (beech, European larch & pedunculate oak), 14 (species as per compartment 13), 18 (beech, hybrid larch & pedunculate oak), 20 (species as per compartment 18) and 21b (beech, pedunculate oak and Scot's pine), 21c (beech, pedunculate oak on the Scheduled Monument) and 23 (beech and pedunculate oak) are all identified for thinning in the woodland management plan. This is compatible with the restoration of historic views and in all cases the native broadleaved species should be favoured for retention over larch. Ideally an irregular edge to the woodland should be established to reflect historic character and allow views from the Great Terrace as shown below in the extract from Ingman's survey of 1773.
